# SUMMARY REPORT OF EXISTING STRUCTURAL CONDITION

Pfiffner Pioneer Park Bandshell  
1100 Crosby Ave.  
Stevens Point, WI 54481

Project No. STEVP21001

September 3, 2021

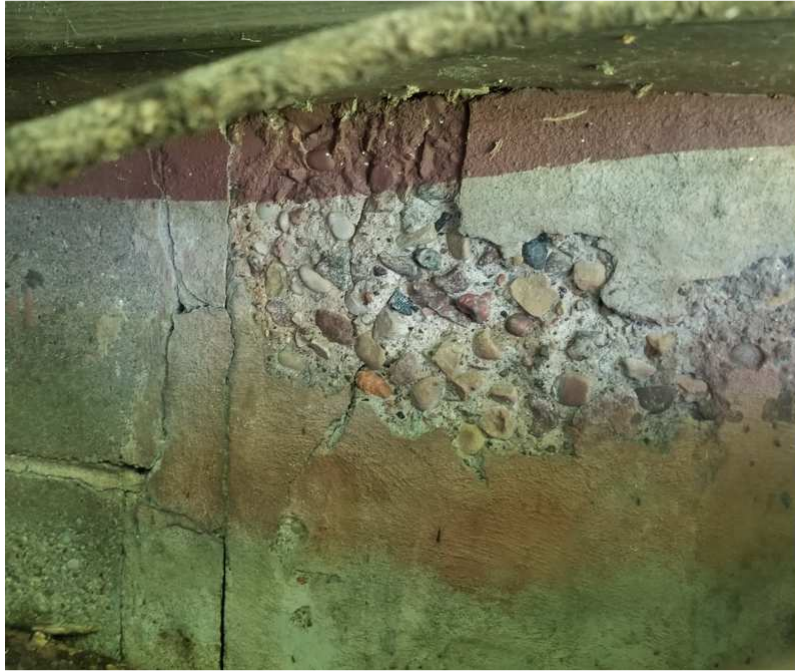
The reinforced concrete footings are in fair to good condition. The concrete surfaces are weathered, with some surface scaling and spalling exhibited. No excessive cracking or settlement was observed. Joints between the pedestals and the slab containing the tension ties were examined for excessive width that could indicate prior overstress in the ties; however, the joint widths were normal.

*Figure 6 – Spalling of Pedestal at Southwest Isolated Footing of Main Arch*

- Repair the roof over the backstage addition to properly secure the roof deck panels and re-apply bonded membrane roofing. Hire an experienced roofing contractor to conduct a survey of the existing roof to verify the cause of the fastener pullouts and determine the extent of damage. The roof decking is part of the building main wind force resisting system, and must be repaired in accordance with the appropriate structural code. In this particular case, it is likely that the interior sheathing is functioning as the roof diaphragm, but this should not be relied on long-term. Repair is assumed to require at a minimum:
  - Re-fastening the roof decking using appropriate fastener types and spacings
  - Installing bonded EPDM roofing
- Apply concrete surface repair to the foundation pedestals to address scaled and spalled surfaces.

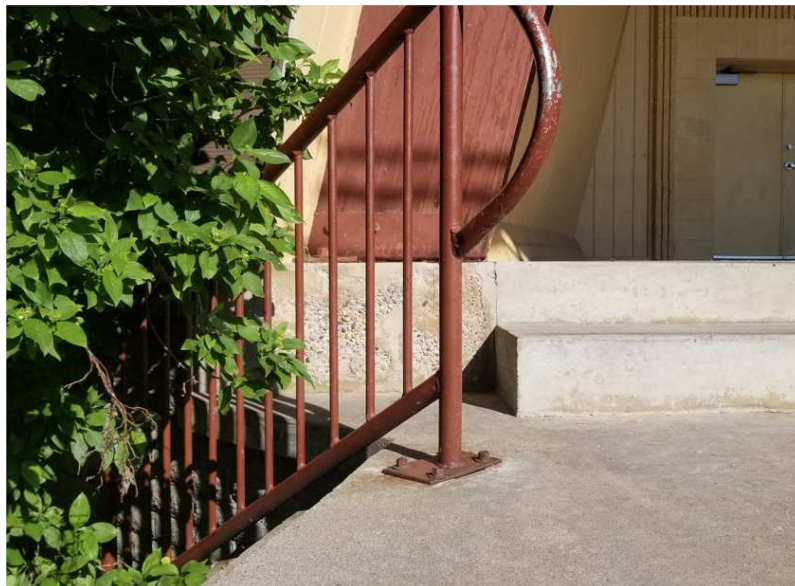
*Figure 7 – Spalling and Scaling of Concrete Pedestal*

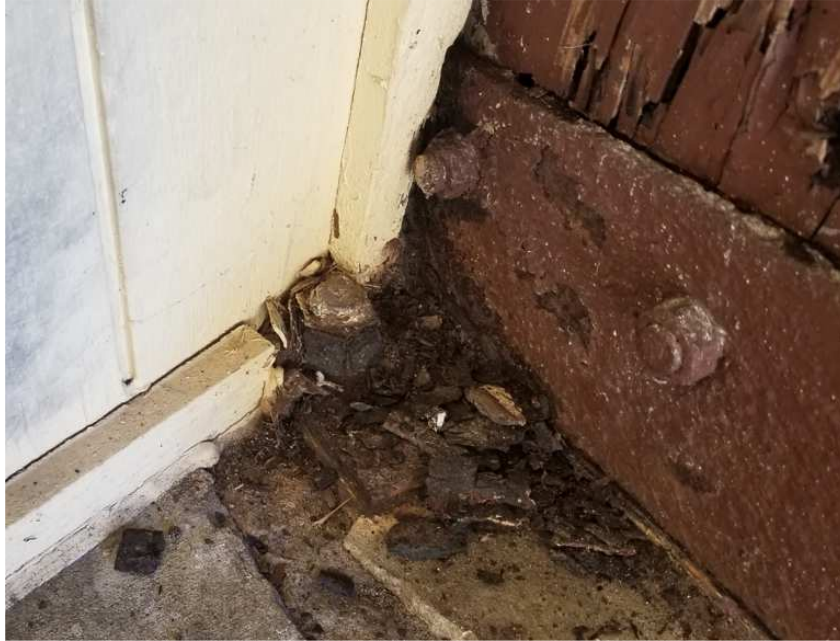
The steel anchor plate assembly at the northeast base of the primary arch has areas of heavy corrosion and pack rust, especially near the concrete anchor and arch thru-bolts. The remaining three anchorages are in good condition.

*Figure 8 – Heavy Corrosion at Back of Northeast Base of Primary Arch*

- Repair or replacement of the anchor plate assembly. At a minimum this work should include blast cleaning, priming with zinc-rich primer, and topcoating

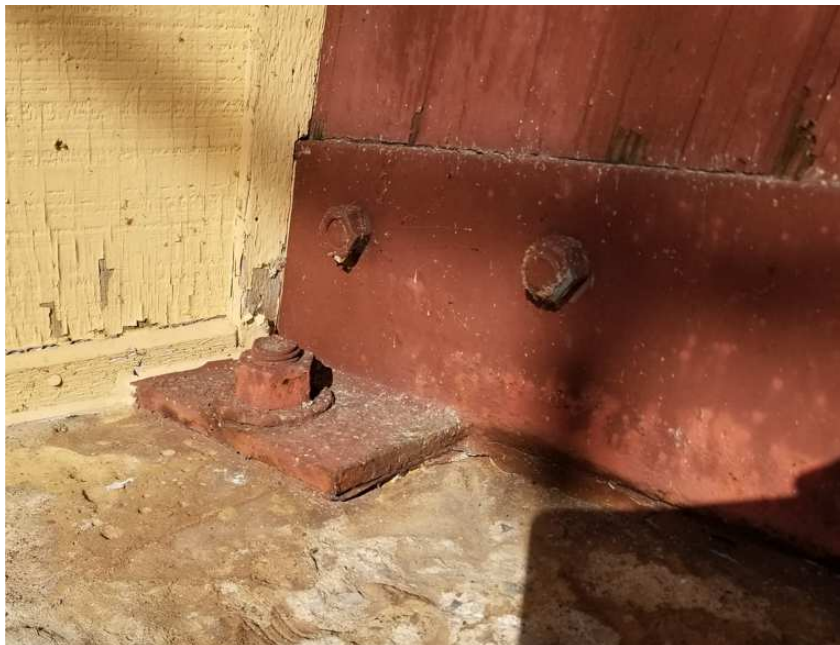
*Figure 9 - Front Side of Southwest Anchorage for Primary Arch*

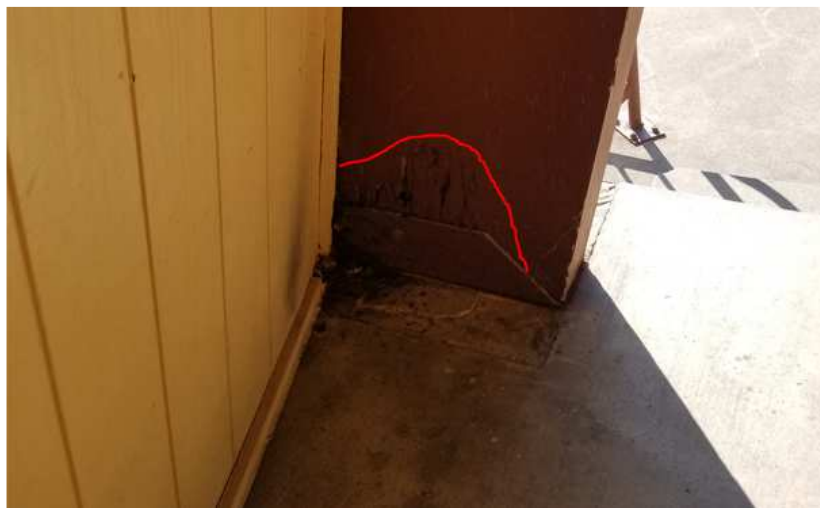
- The larger, primary laminated timber arch has extensive decay at the northeast end of the arch (left side when facing off the stage). The steel baseplate is also heavily rusted with loss of thickness. This is the area of most concern because the majority of the building loads are carried by this arch and are concentrated at this point. No evidence was observed that the deterioration had resulted in overloading yet. However, we recommend prioritizing repair to the base of the arch as soon as possible (ideally within the next 10 months). Partial failure of this part of the structure will lead to more extensive damage to other areas of the building. Repair will involve bracing and shoring the arch, replacing decayed areas of wood in a manner that provides adequate strength, and repairing and coating the base plate to strengthen the anchorage and prevent further corrosion. We further recommend flashing the bottom 4 feet of the back side of the arch to prevent further exposure of the arch to sources of moisture that have accelerated the decay.

The primary laminated timber arch has extensive decay occurring at the base connection to the northeast anchorage. The finish has failed on the front face of the arch and surface decay estimated to be ½" maximum is occurring over much of the width. Deterioration of the back face of the arch is considerably more advanced. Probing of the decay indicates that 50% or more of the section at this location is decayed, especially the area surrounding the bolted connection to the base plate. The extent of decay extends approximately 16" up the back face of the arch, across the most of the width of the back face, and through 50% or more of the thickness of the arch section. The arch base was examined for evidence of overload of the remaining section, such as crushing, cracking, or sliding of the base but no such evidence was observed at the time of inspection.

*Figure 10 - Decay Extent (Red Line) on Back Face of Main Arch at Northeast Base*

- Repair the decay in the primary arch at the northeast base is the highest priority. This work will require a contractor skilled in installation and repair of glulam structures. The repair is expected to include the following work:

- Temporary removal of the walls adjacent to the arch to fully expose the repair area
  - Removal of decayed laminations in a manner that facilitates a lapped-type repair

- Replacement of temporarily removed wall
  - Removal of temporary shoring
  - Installation of flashing or urine resistant coating to back face of the arch is recommended to prevent future deterioration

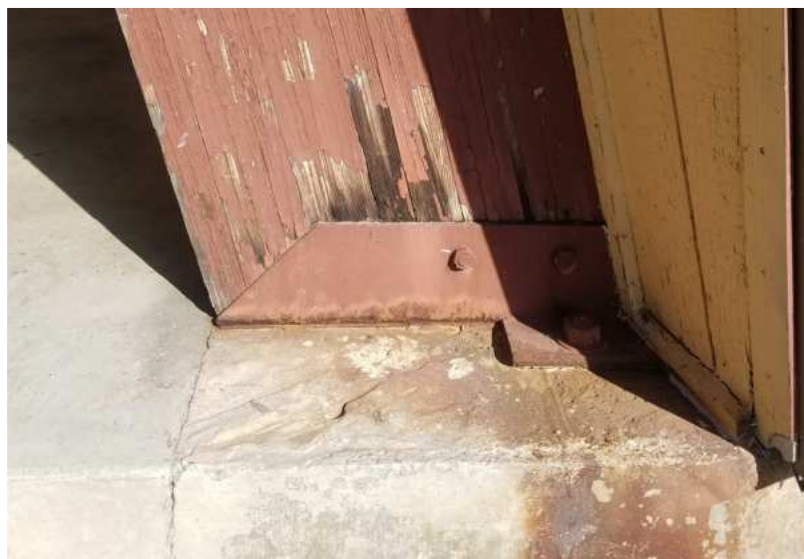
*Figure 11 – Front of Main Arch Northeast Base- Loss of Finish with Shallow Decay*

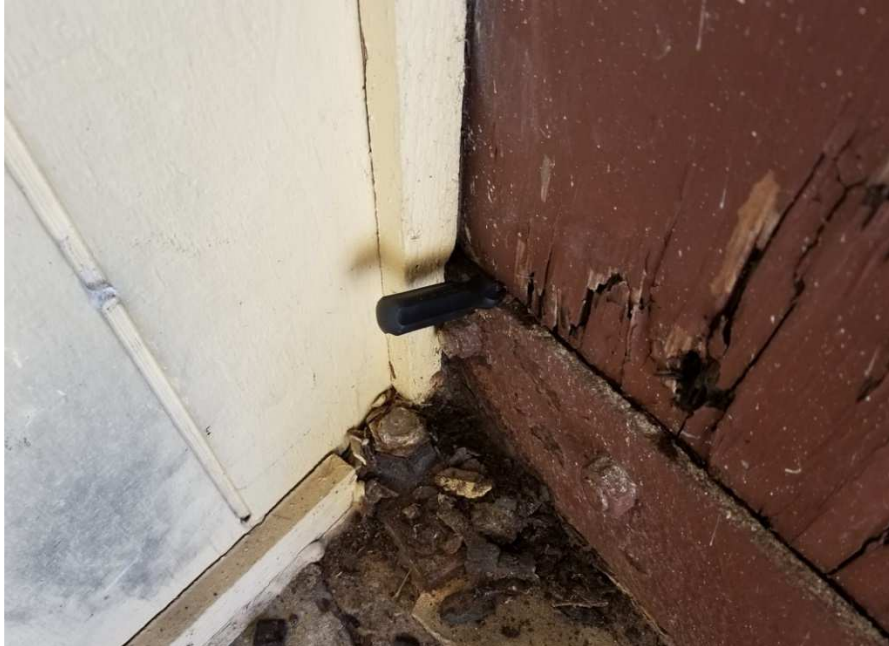
*Figure 12 – Extensive Decay at Back of Main Arch Northeast Base – Exceeds 4" Probe Length*

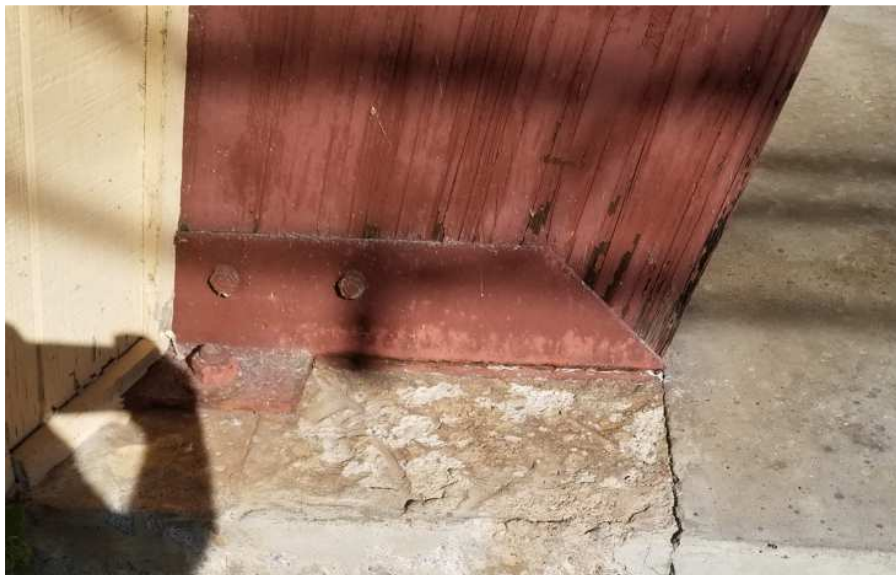
Some finish failure and surface decay was present at the southwest arch base as well. The deterioration at this base was much less extensive and does not appear to substantially affect the section strength. Finish failure and surface decay were observed to be limited to the lower 6" of the front face of the arch. The rear face of the main arch was in good condition at this location.

*Figure 13 – Finish failure and Surface Decay at Front Face of Southwest Arch Base*

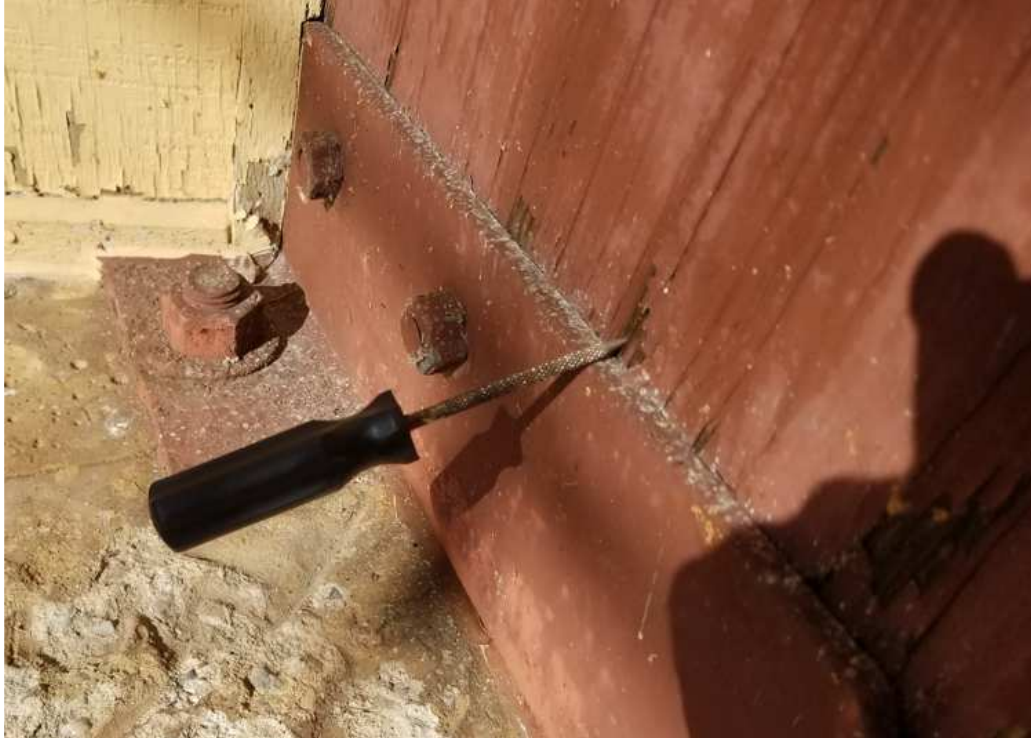
*Figure 14 - Limited Probe Penetration into Surface Decay of Front Face on Southwest Base*

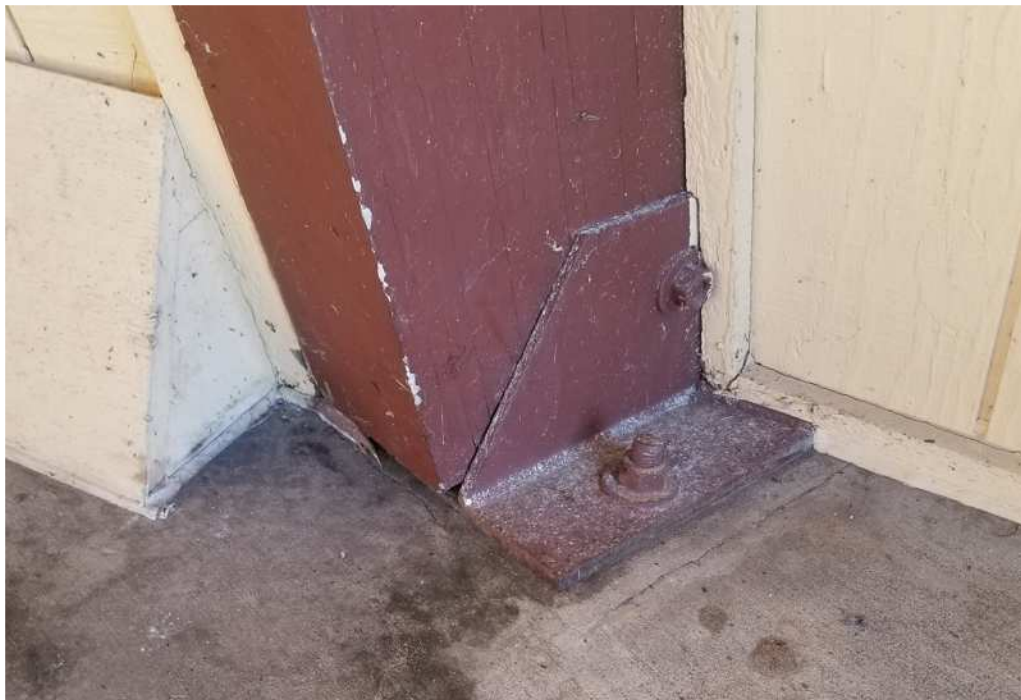
The secondary arch was in good condition throughout with no areas of decay observed. This includes the arch base area at the anchorage connection as well. Similar to the main arch, the finish is cracked with small areas that are chipped or peeling, but no areas of decay were observed. The northeast arch base does appear to be under uplift in the anchorage as evidenced by the gap under the arch base and the thru-bolt alignment. Uplift at this location is to be expected given the large cantilever geometry. The continuity of the finish from the anchor plate to the arch and lack of any chaffing indicates that this connection does not move frequently.

*Figure 18 - Northeast Base of Secondary Arch - Note Gap Under Arch*

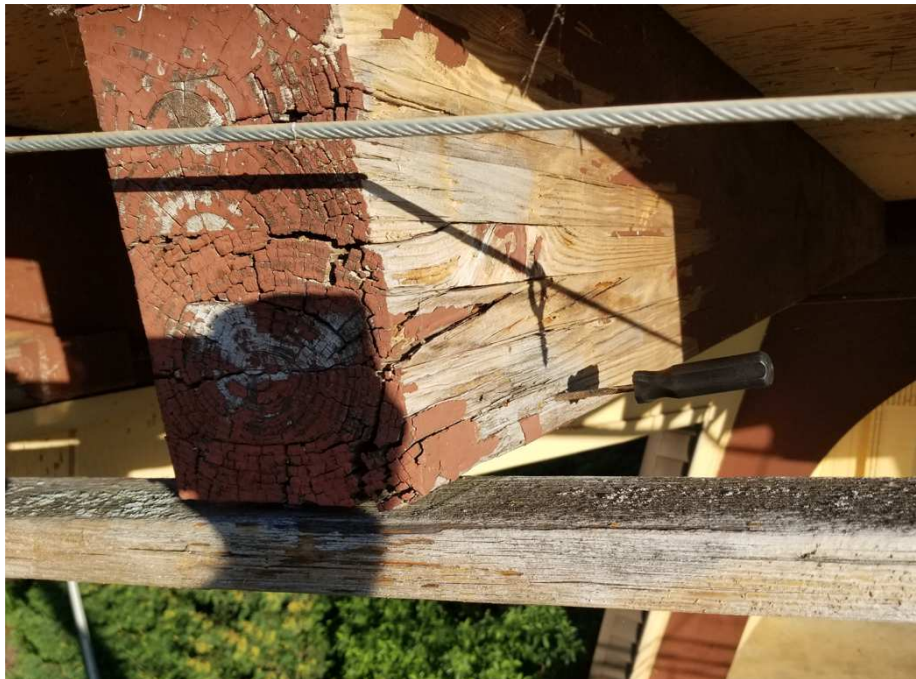
- The ends of the rafters at the eave of the canopy have decay due to exposure of the end grain. The decay extends up to 12" back from the ends of the rafters. Transverse bracing is attached to the bottom of the rafters in this area. Failure of the bracing connection may allow the long cantilever rafters to twist under high loads. Also, lighting and rigging are attached to this portion of the rafter. Pullout failure of those fasteners could result in falling lighting or other heavy equipment with an attendant elevated risk of injury. We recommend the ends of the rafters get mitered and flashed to limit exposure of end grain to precipitation. Any structural elements, lighting, or rigging attachments should be relocated out of the region affected by decay and should be detailed to avoid fastening into the end grain.

*Figure 19 – Exposed Rafter End – Note Gap Between Lateral Brace and Underside of Rafter Indicating Fastener Pullout. Decay Extends 6"-12" from End (Typ.) on Bottom of Rafter*

- Install new lateral bracing to the rafters. this bracing should be installed approximately 2' from the existing end of the rafters to avoid decayed areas. The top of the bracing should be flashed to eliminate the permeable horizontal surface that accelerates water absorption into the brace.

- Modify the exposed rafter ends to arrest further decay. We recommend mitering the end 30°-45° from the vertical to removed most of the decayed wood. Flashing should then be installed over the exposed end grain with an air gap (1/2") between the end grain and the flashing to prevent wicking of moisture and to allow air exchange.

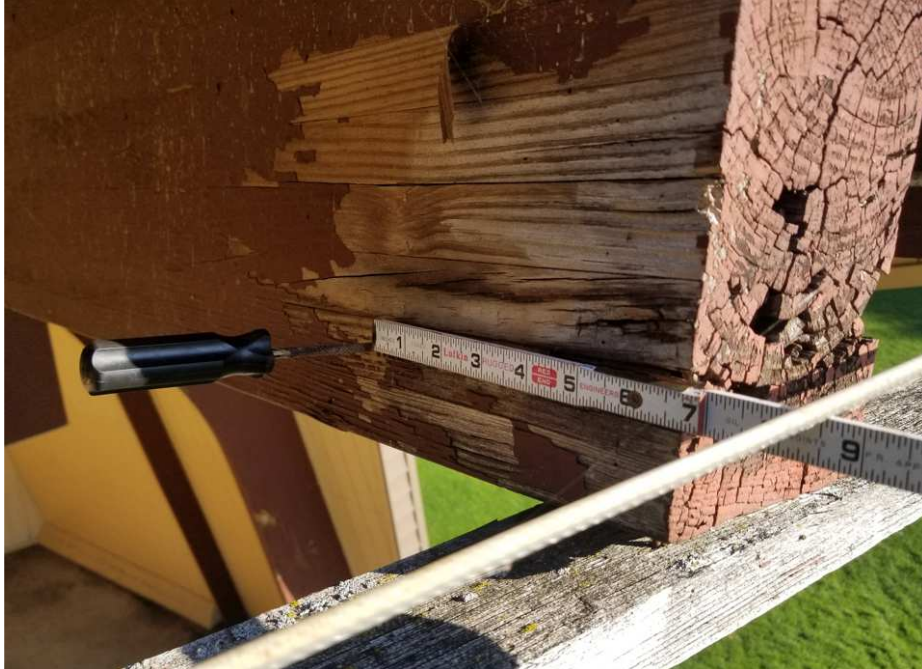
*Figure 20 - Exposed End of Rafter Showing Extent of Decay and Pullout of Bracing Fasteners*

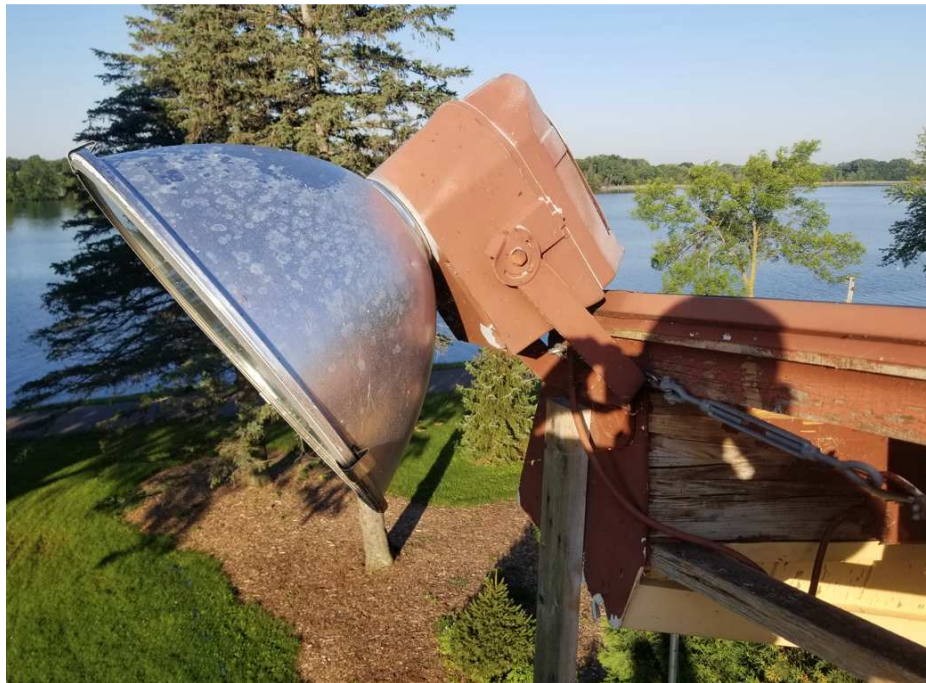
*Figure 21 - Typical Lighting Connection into End Grain of Rafter*

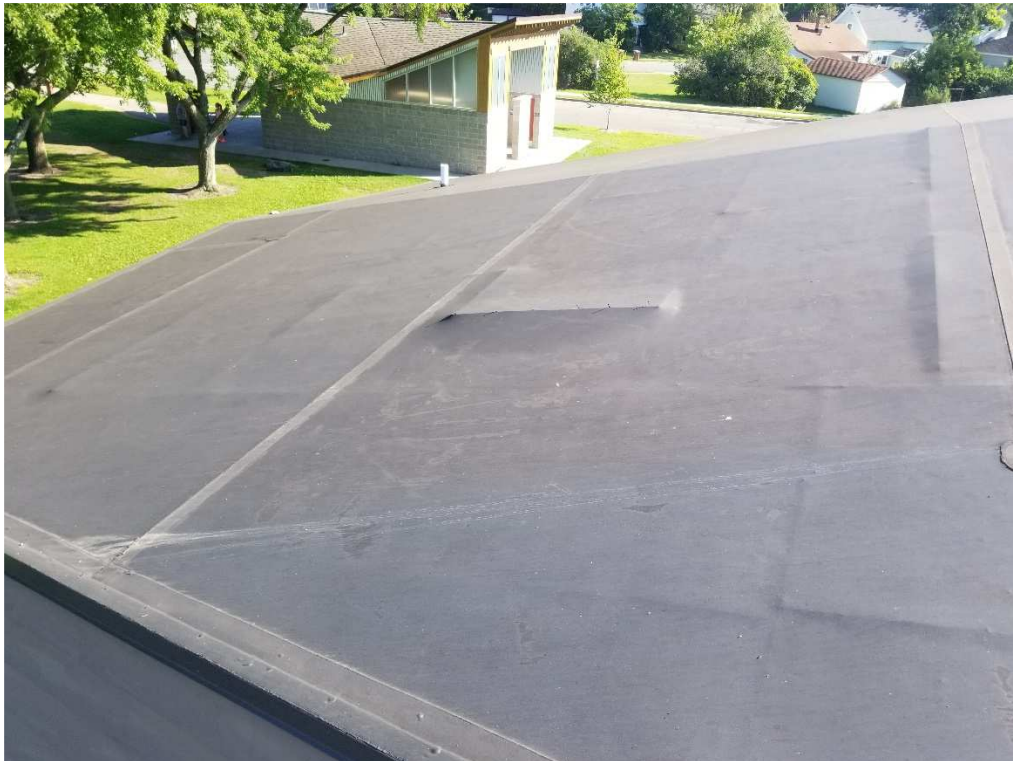
- The roof deck panels on the 2002 addition at the back of the bandshell are becoming detached from the underlying roof framing. This has resulted in lifting or curling of the deck panels and, in some locations, fasteners pushing through the roofing membrane. Although not a definitive reason for the failure, the apparent fastener spacing seen where fasteners have pushed through the membrane do not appear to meet the minimum standard required for roof deck fastening. The roof deck panels form part of the building main wind force resistance structure. Failure of the fasteners compromises the ability of the building to resist wind forces and further compromises the weathertight properties of the roof membrane. The roof over the addition should be surveyed by a reputable roofing contractor to verify why the fasteners are pulling out and the panels are lifting. We advise having an engineer on site when the roofing contractor exposes the decking to help determine if the failure is due to structural overload or improper installation. Repair is expected to be removal of the roof membrane, replacing any decking that decayed as a result of moisture intrusion, fastening all roof decking per code requirements, and placing a new membrane.

The roof over the backstage area addition is in poor to fair condition. Many of the roof deck panels have lifted to some degree, with the panels appearing curled upward and the joints between panels clearly visible under the membrane. In some locations the decking fasteners have worked upward to the point where they now project through the roof membrane. Although the membrane is clearly perforated, this does not appear to have led to visible staining or decay on the interior sheathing. The fastener spacing appears to be approximately 9", 50% greater than the maximum fastener spacing of 6" for edges of sheathing panels that is appropriate for this wind speed zone. Further investigation with the help of an experienced roofing contractor is recommended to properly expose the affected roof sections, identify the cause of failure, check the underlying I-joists for damage, and reapply the roof membrane.

*Figure 27 - Sheathing Panel Lifted Approximately 2" with Fasteners Pushed Through Membrane Roofing*

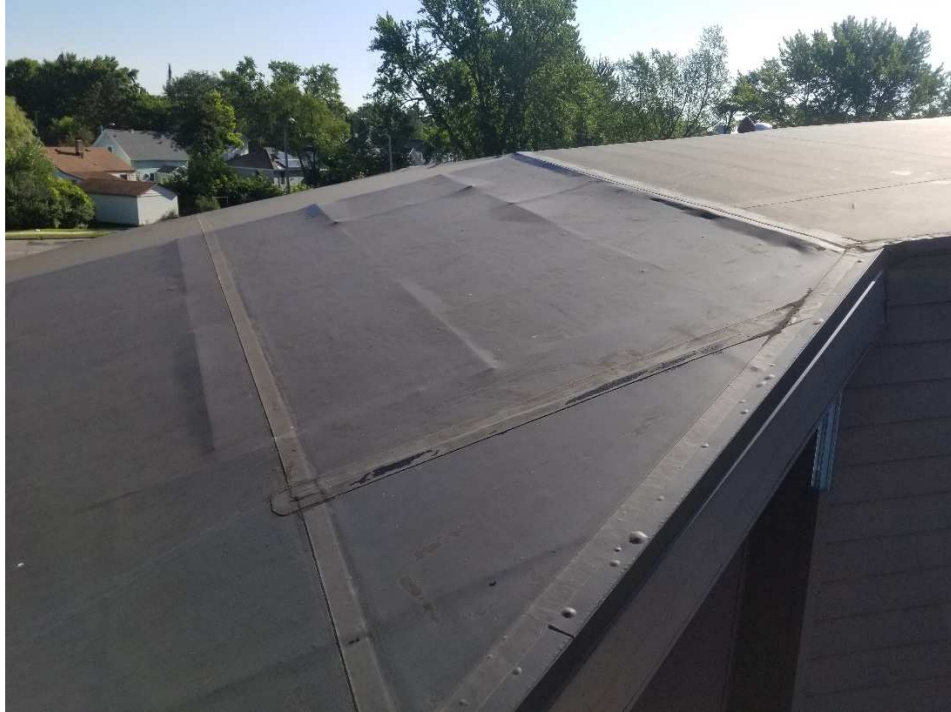
*Figure 28 - Widespread Lifted Roof Sheathing Edges and Curled Panels in Addition Roof*
