**REGULAR MEETING
Board of Park Commissioners
November 6, 2024 - 6:30 PM**

4. Review of preliminary condition report of Donald Copps Municipal Pool.

During the site visit, the pool was empty to allow for a close-up evaluation of the pool basins. The following items were noted based on the on-site evaluation, several discussions with City of Stevens Point staff, and review of previous construction plans.

This report provides a summary of noted concerns and potential improvements for consideration by the City of Stevens Point. Photographs can be found in **Appendix A** for reference. Initial photos 1, 2, and 3 provide an overall view of the existing pools at the facility.

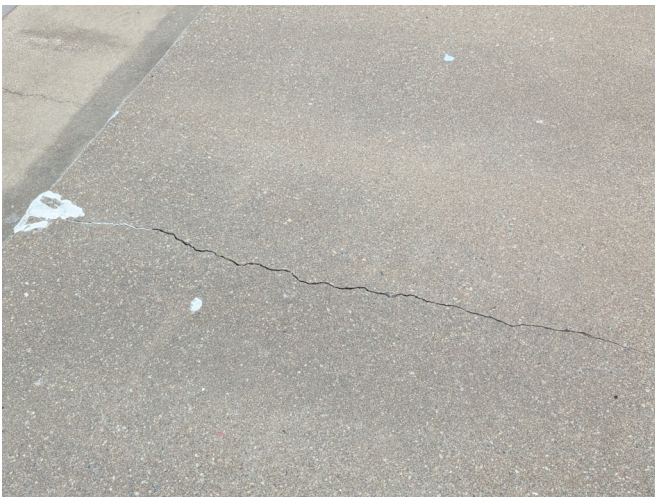
- Deck Settlement – The pool deck southeast of the main pool diving hopper has settled. There was over an inch difference in elevation between portions of the pool deck that was spray painted by staff. This is a tripping hazard on the deck and will continue to get worse until corrected. Additionally, the pool could begin settling leading to uneven skimming from the gutter.

1. Pool Area Concrete Deck: Overall, the deck is in fair condition, with some settlement observed around the main pool diving hopper, surge tank, and outdoor heater location. Settlement is likely caused by a leak in the nearby surge tank. The deck should be repaired but the source of the leak will need to be verified and repaired first. Additional cracks and chips were noticed in the deck around the plunge pool and wading pool. See photos 4, 5, and 6.

4. VIEW OF LOCATION OF DECK SETTLEMENT.

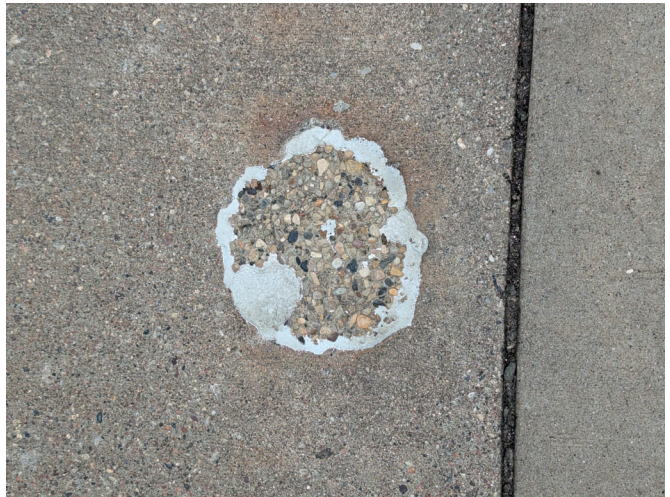
5. VIEW OF CRACK IN POOL DECK.

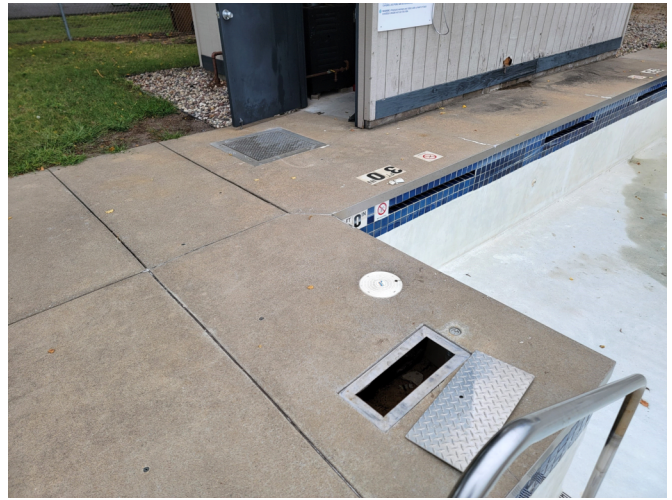
7. VIEW OF POOL DECK BEHIND DIVING BOARD.

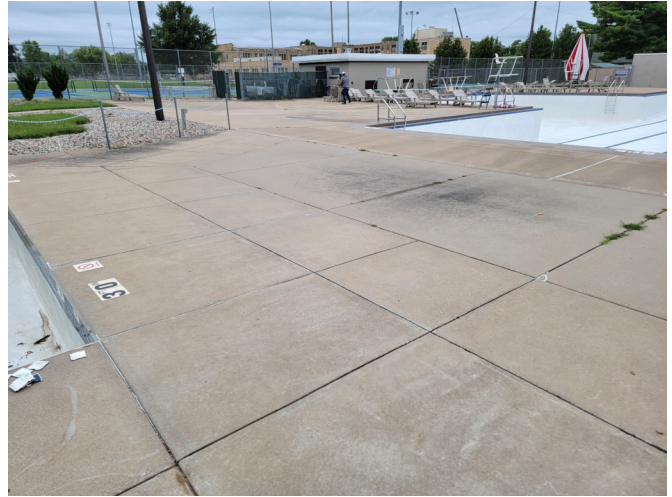
3. Pool Deck Drains: There are three area drains around the main pool and a trench drain between the main pool and the wading pool that appear to be functioning adequately. There are no deck drains between the main pool and the plunge pool. The deck in this area appears to have improper slopes resulting in “ponding” water on the deck, which is not code compliant. Reconstructing the deck and/or adding deck drains in the area may be necessary. See photos 9 and 10.

9. VIEW OF DECK DRAIN BETWEEN MAIN AND WADING POOLS.

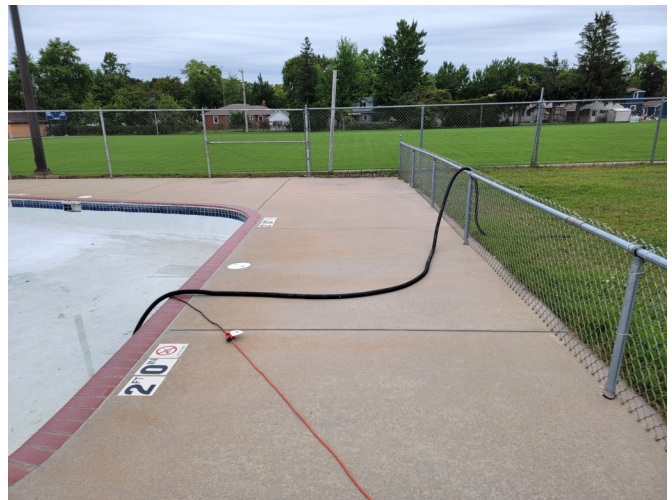
4. Pool Depth Markers: A couple of depth markers are broken and chipped. Broken and chipped depth markers can lead to sharp edges on a pool deck and should be replaced. The remaining depth markers are compliant with code. “No diving” markers are also present and in the necessary locations. See photo 11.

11. VIEW OF CHIPPED DEPTH MARKER.

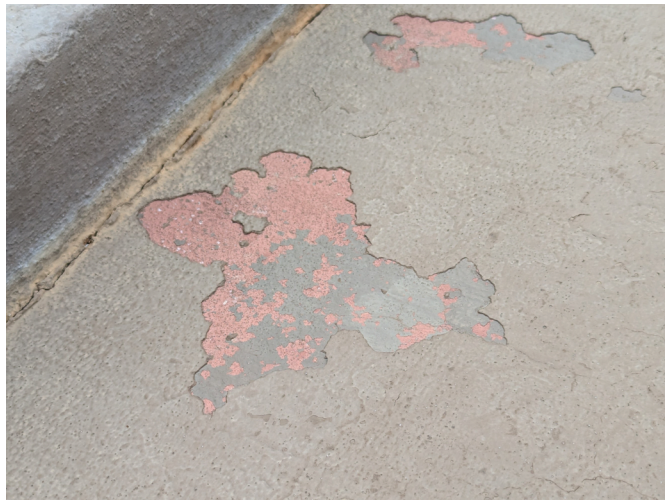
2. Pool Perimeter Overflow Gutter: The gutter has been modified from original construction and does not have the original finger grip and tile finish. The current gutter finish appears to be paint that is chipping in some locations. The joints are worn down creating a low spot in the gutter and a sharp edge. The expansion joints will need to be filled with epoxy to be flush with concrete and the loose paint will need to be removed and the whole gutter should be repainted. See photos 15, 16, and 17.

15. VIEW OF GUTTER DROPOUT AND CHIPPED PAINT IN GUTTER.

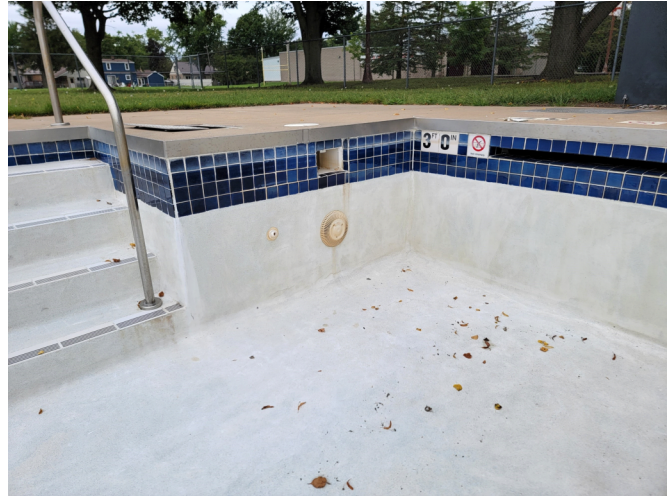
The plunge pool basin is the newest basin that was constructed in 1990. It consists of the basin for the slide and a balance tank for the surge created by patrons using the slide. City of Stevens Point staff completed a bucket test for the plunge pool and noted a drop in water elevation. The bucket test was completed with the recirculation and slide systems shutdown. See photo 25.

25. VIEW OF PLUNGE POOL.

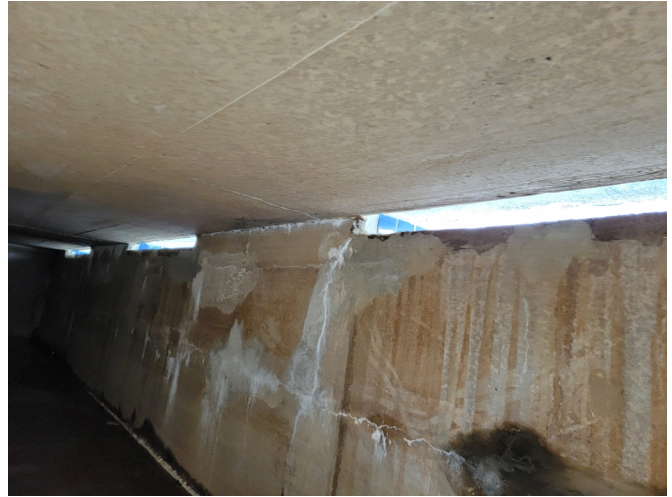
2. Pool Overflow System: The plunge pool uses four skimmers for recirculation and three weirs into a single balance tank for the slide. The skimmers appear to be in good condition but do require updates to the equalizer fitting on the walls to maintain VGBA compliance. The weir tank has a few cracks near the top of the tank. The operating water level in the balance tank is below the crack and when the slide system is shut off, the water level should rise. See photos 26, 27, and 28.

27. VIEW OF INSIDE WEIR TANK.

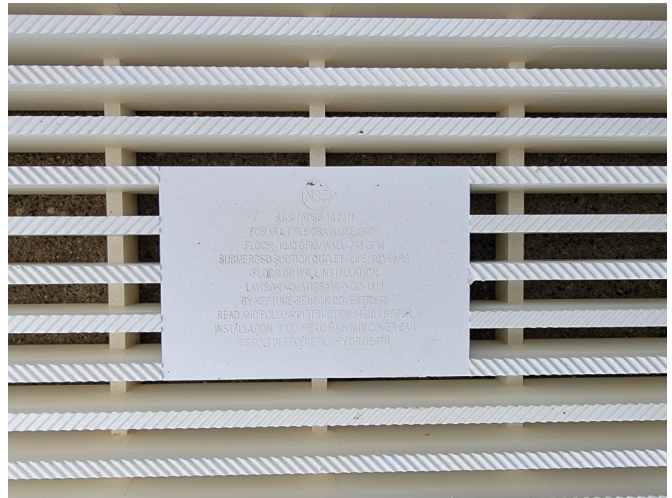
3. Filtered Water Inlets: The plunge pool uses six wall inlets that appear to be in good condition.
4. Main Drain(s): A single 18"x36" VGBA approved drain is installed. The sump depth was measured to be 13". Due to updated VGBA requirements, when the main drain grate is replaced in the future, the grate manufacturer will have to verify the existing sump is compliant with new grate, or else both the grate and sump will have to be replaced. See photos 29 and 30.

29. VIEW OF MAIN DRAIN IN PLUNGE POOL.

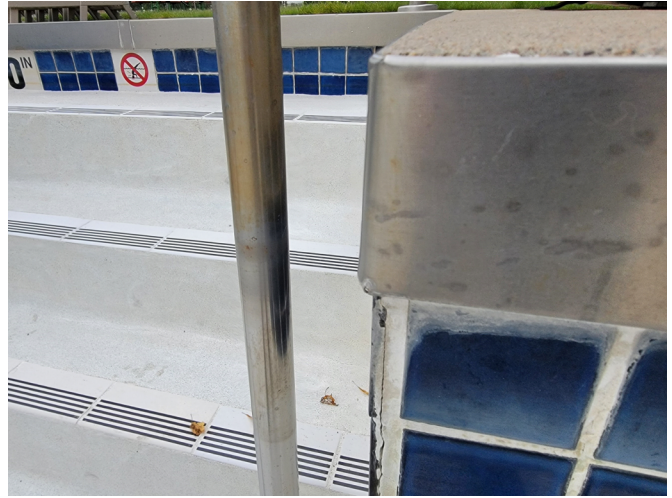
32. VIEW OF STAINLESS STEEL COPING EDGE.

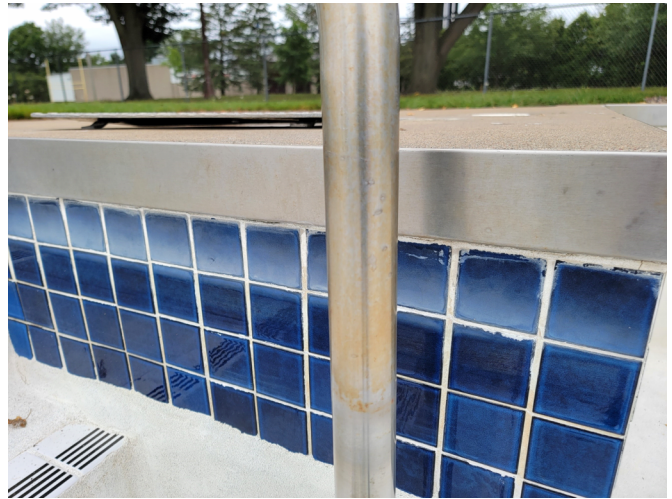
6. Basin Depth: The plunge pool water depth is 3'-0" by the stairs and 3'-6" by the slide terminus.
7. Pool Stairs: The plunge pool stairs are in good condition but there is minor surface corrosion. The railings should be cleaned to remove the corrosion. The stairs were constructed with four 11" treads and five 9" risers. The stair railing does not appear to remain parallel with the nose of the stair treads. This should be addressed when removing the corrosion. See photos 33 and 34.

34. VIEW OF CORROSION ON HANDRAIL.

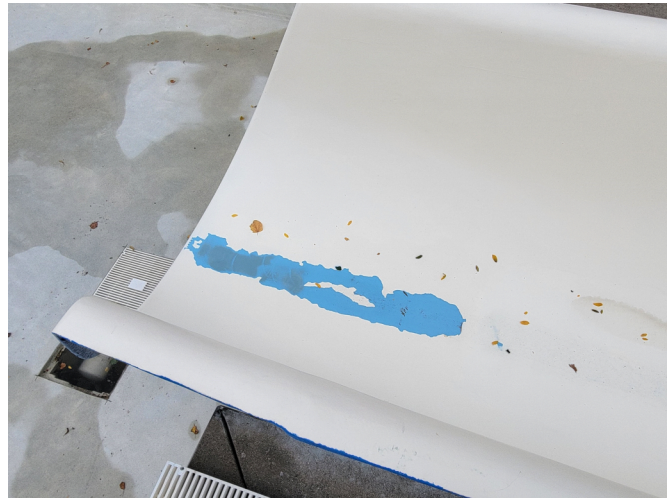
The waterslide was refurbished about five years ago. The slide terminus has discoloration in the flume from patrons and water going through the slide. Loose paint should be removed and then repainted to match the remaining slide. See photos 35 and 36.

36. VIEW OF CHIPPED PAINT AT SLIDE TERMINUS.

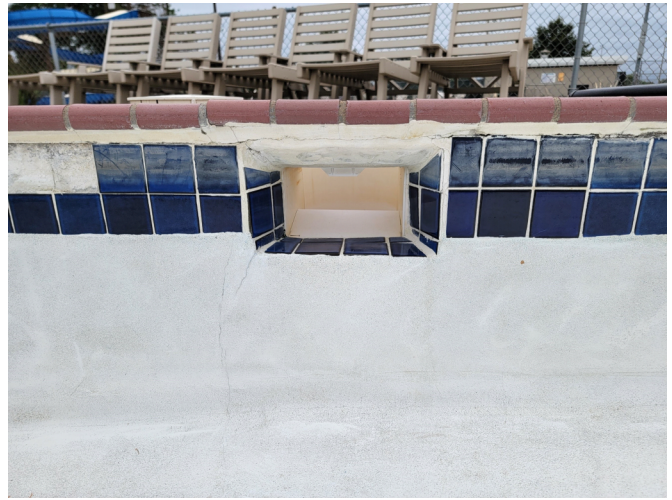
1. Pool Piping: The piping is PVC and there were no visible problems.
2. Pool Skimmers: The wading pool recirculation system uses three skimmers. The skimmers appear to be in good condition and previous VGBA plans have the equalizers to the main drain sump, removing any potential compliance issues. See photo 38.

38. VIEW OF SKIMMER IN WADING POOL.

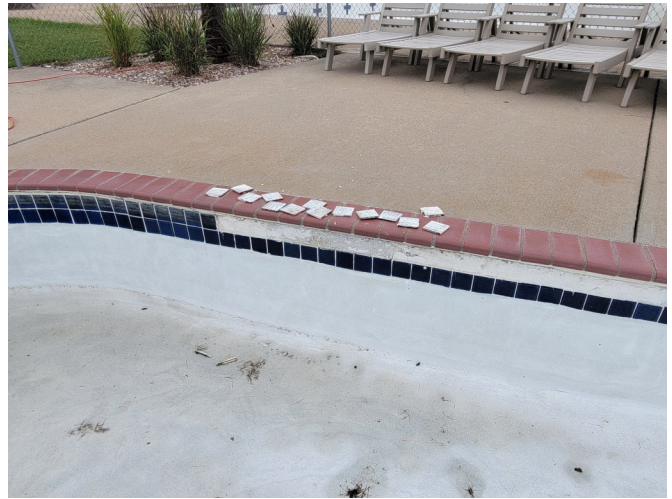
5. Basin Shell: The pool basin finish consists of plaster and tile. Waterline tiles around the basin are missing or broken around the perimeter. Missing and broken tiles should be replaced. The pool coping is red brick with a bullnose. There is a noticeable caulk or epoxy joint between the waterline tile and the coping. This joint is above the operating water elevation and water leakage shouldn't be a concern. See photo 40.

40. VIEW OF MISSING WATERLINE TILE IN WADING POOL.

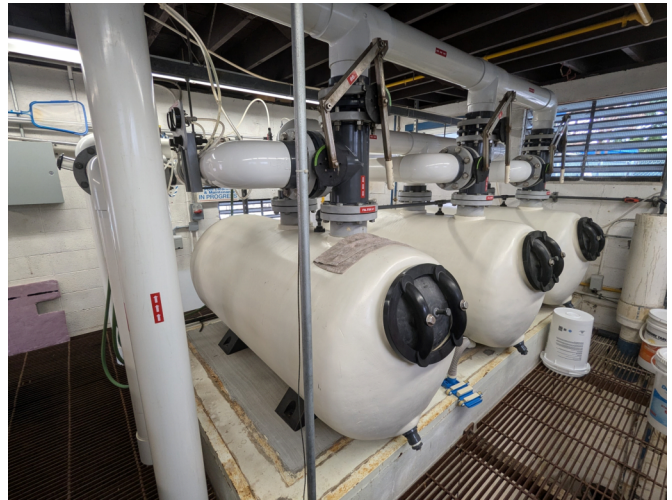
- *Recirculation Pump*: One 20 HP Aurora 3800 Series pump in good condition. See photo 41.
- *Filter*: There are three Pentair THS horizontal sand filters in good condition. See photo 42.

42. VIEW OF MAIN POOL FILTERS.

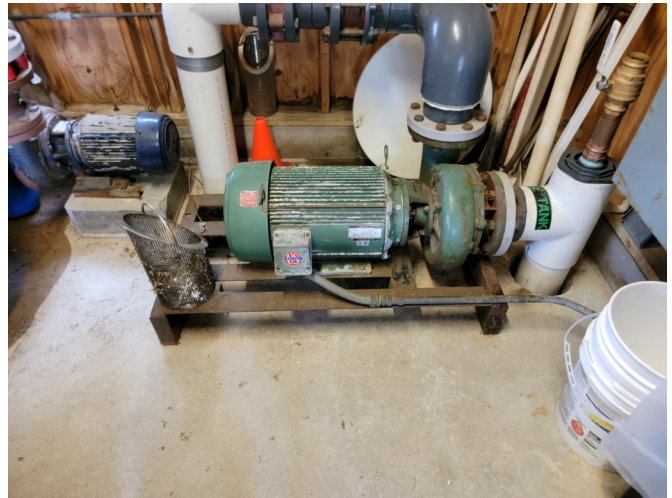
- *Slide Pump:* One 20 HP pump is used to supply the slide. The pump is starting to show corrosion, and the protective paint is chipping off the motor. See photo 48.
- *Filter:* There are three Pentair Triton II – TR-140 sand filters in good condition. See photo 49.
- *Pool Heater:* One Rheem heater is installed for the plunge pool. The heater draws combustion air from inside the equipment room. With the pool chemicals being stored in the same room, the heater should be thoroughly inspected at the end of every pool season. See photo 50.
- *Chemical Feed Equipment:* Liquid chlorine and acid are stored in the same room as the rest of the pool mechanical equipment. Chemical feed pumps are Blue-White, and the controller is a BECSys3. See Photo 51.

48. VIEW OF SLIDE PUMP.

With updates to the energy code, the existing pool recirculation and slide pump assemblies are no longer available. If either pump fails, finding parts will be challenging. If a pump fails and replacement is required, State approval will be required prior to installation of the new pump. The need for State approval will force the pool to be shut down for an undetermined period of time while the State reviews the new pump specifications.

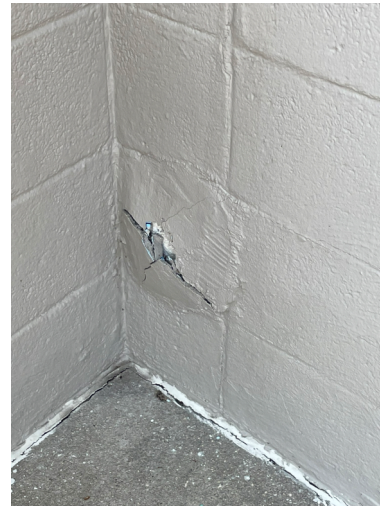
60. VIEW OF CRACK AND BULGE IN BUILDING MASONRY.

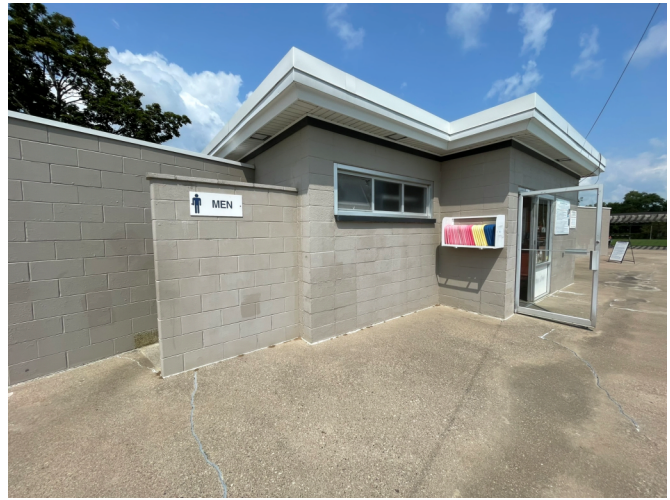
62. VIEW OF CRACKED CAULKING AT BASE OF BUILDING.

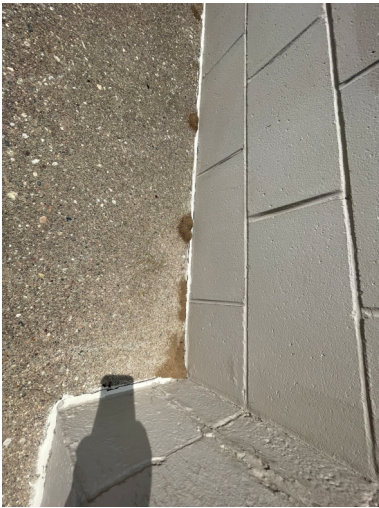
63. VIEW OF ANT MOUNDS AT BASE OF BUILDING.

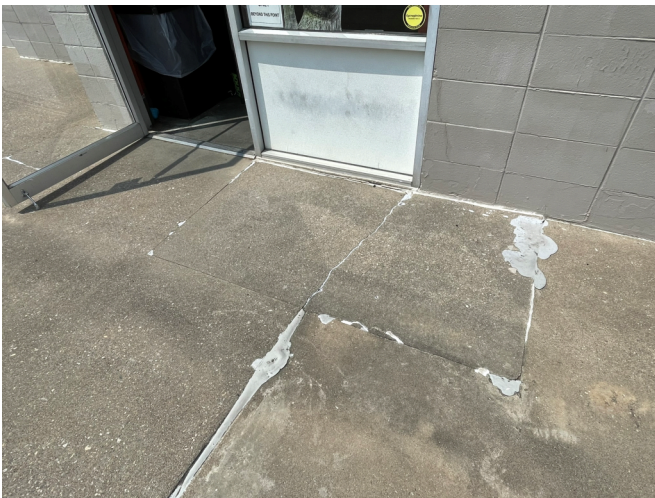
65. VIEW OF CRACKING IN DECK AROUND BUILDING.

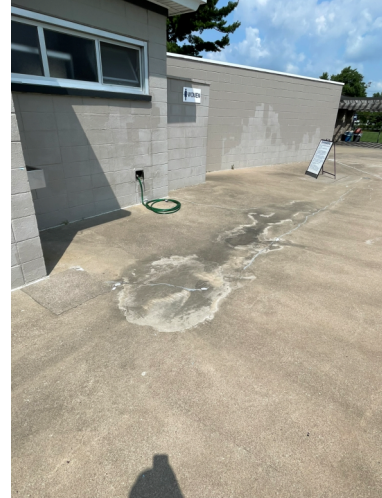
66. VIEW OF LOW SPOT BY BUILDING.

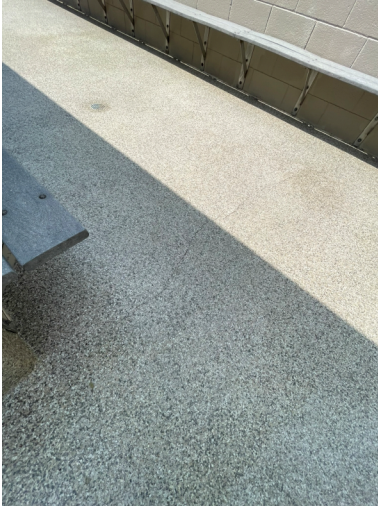
Transitioning back from the pool deck into the Men's locker rooms, the floor surface goes from concrete on the deck to an epoxy finished concrete in the locker rooms. The epoxy is cracked, peeling, or altogether missing in numerous locations. Originally, the epoxy appears to have been rolled up the CMU wall surface roughly four inches, with an intentional seam incorporated. Throughout the outdoor locker rooms, the epoxy is cracked or missing at the transition from floor to wall, see photos 67, 68, 69, 70, and 71. There are areas of discoloration directly below hose bib

67. VIEW OF CRACK IN EPOXY FLOORING IN CHANGING AREA.

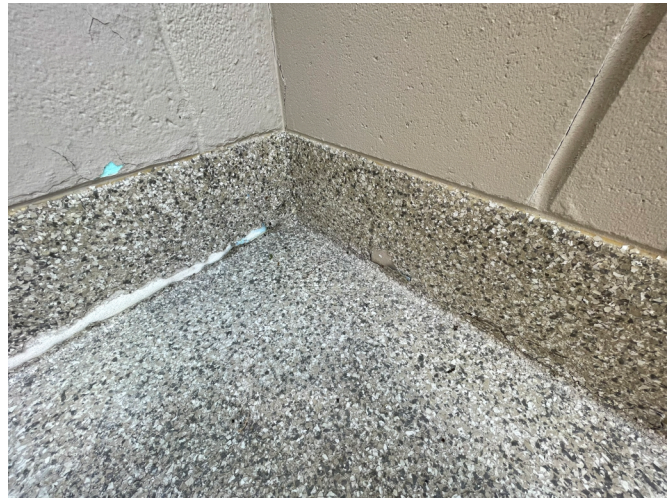
68. VIEW OF MISSING EPOXY IN CORNER.

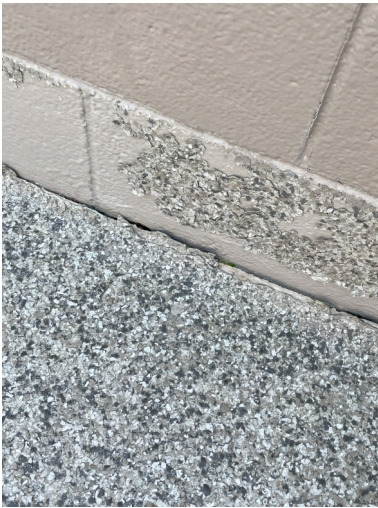
69. VIEW OF MISSING EPOXY.

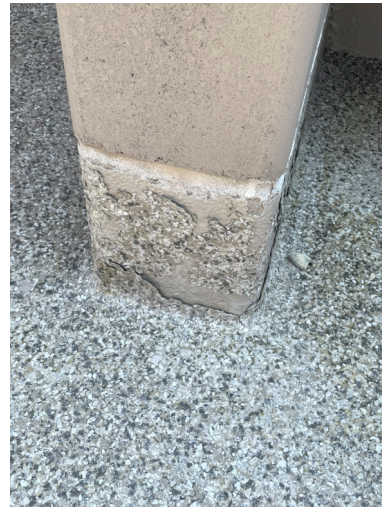
70. VIEW OF MISSING EPOXY.

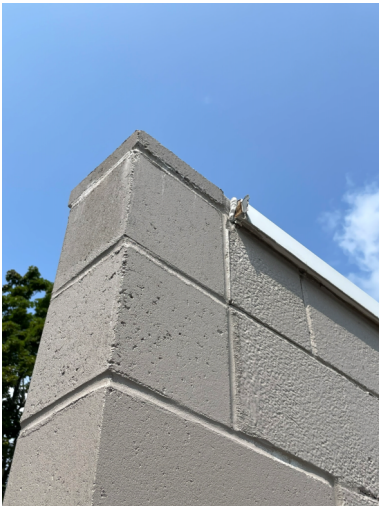
75. VIEW OF MISSING COPING EXTENSION.

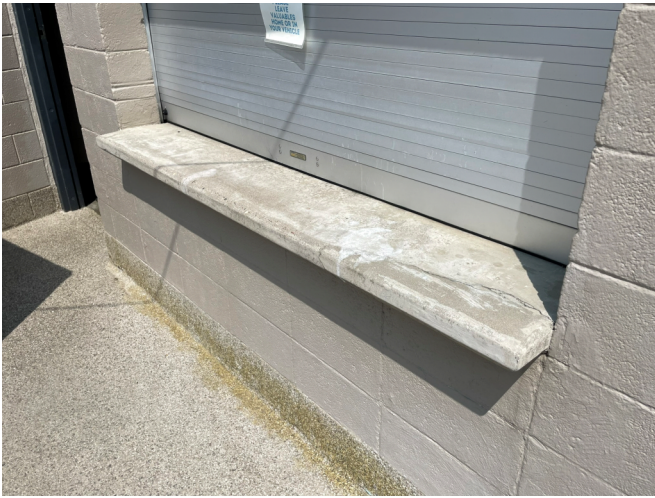
enclosures as well as epoxy and/or paint missing along the seam between the two, see photos 72 and 73. There is a left-over remnant of a prior heightened wall portion leading out into the locker areas. It appears these vision walls were lowered to enhance visibility for safety purposes. The area of prior connection was never sanded down or painted to match, see photo 74. The center divider wall of the Men's locker room is missing coping extension at the end, see photo 75. New shower fixtures appear to have been installed in place of older fixtures; they appear in good working condition, see photos 76 and 77. There is an overhead door with a concrete counter for office staff to provide service into the locker room, at each locker room, see photo 78. The concrete counter of the Men's Locker Room shows a significant crack at the corner, which appears to have been re-attached at some point. It appears close to coming off, see photos 79, and 80.

79. VIEW OF CRACK IN MEN'S COUNTER.

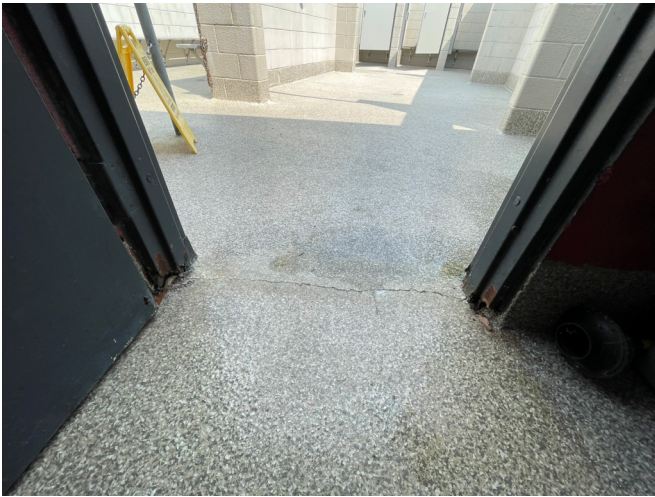
The doors and door frames leading into the toilet and sink areas within the locker rooms, are heavily rusted and in some cases completely gone, see photos 81, 82, 83, and 84. Within the restrooms, the ceiling has been removed; it appears to have been due to moisture mitigation concerns. Some minor staining is visible to the underside roof structure, see photos 85, 86, and 87. As similar on the exterior, interior CMU walls show some cracking at the grout between the wall and window penetrations, see photo 88. The window framing itself has also become detached, again due to moisture present in the space. Additionally, there are two single-use restrooms located on the outer perimeter of the main facility building, flanking the entrance. Both are accessible to the public from the front. Each features a concrete floor showing aging with various cracks and fill efforts over the years. Both have ceilings with significantly peeling paint, most likely due to minimal ventilation over the years. See photos 89, 90, 91, 92, 93, and 94.

81. VIEW OF CORROSION ON DOOR FRAME.

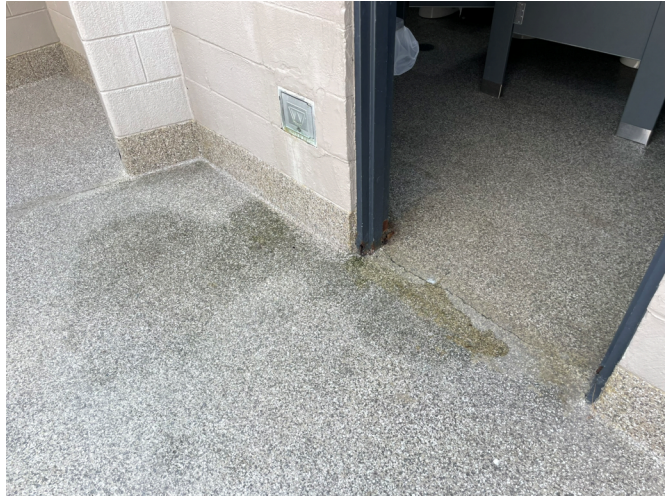
82. VIEW OF CORROSION ON DOOR FRAME.

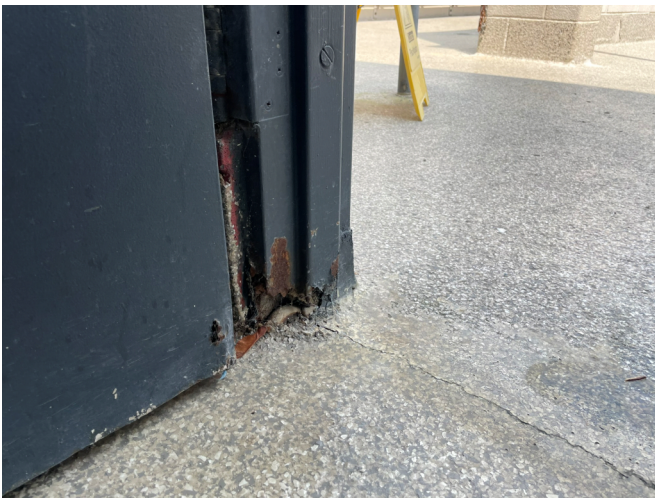
83. VIEW OF CORROSION ON DOOR FRAME.

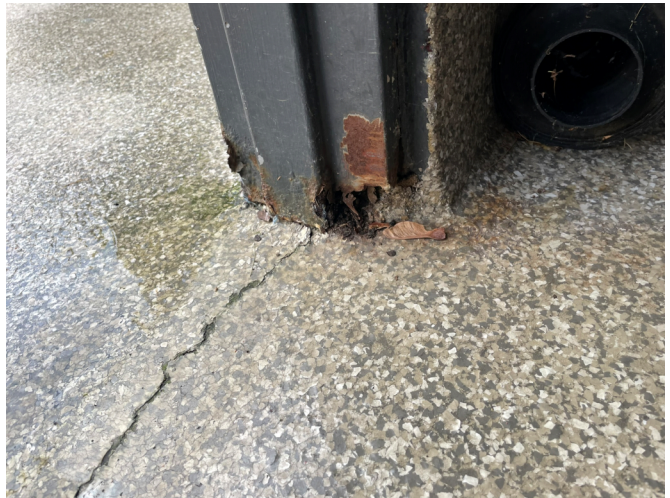
84. VIEW OF CORROSION ON DOOR FRAME.

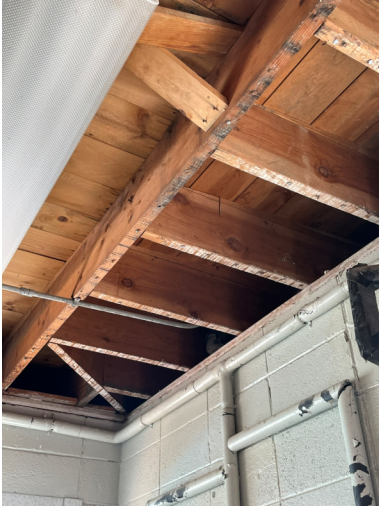
85. VIEW OF STAINING UNDER ROOF STRUCTURE.

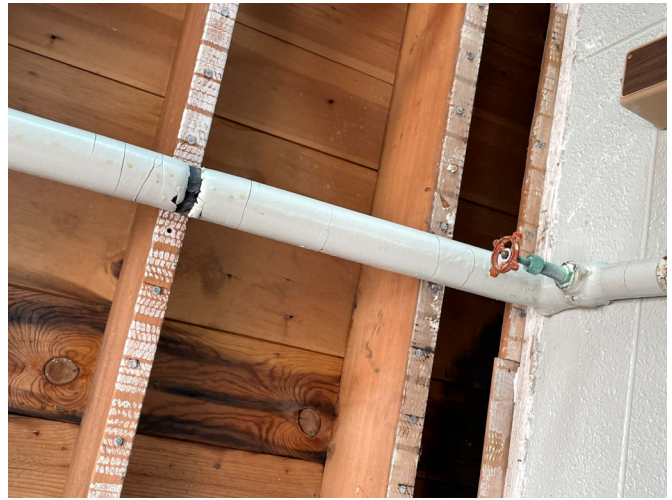
86. VIEW OF STAINING UNDER ROOF STRUCTURE.

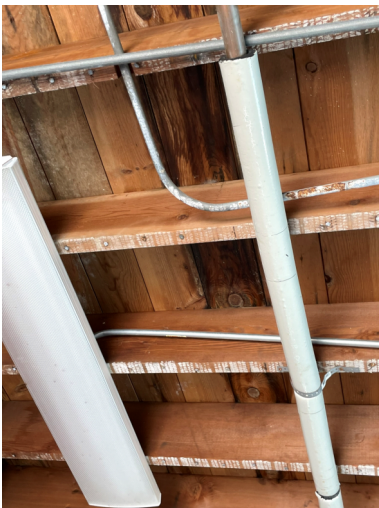
87. VIEW OF STAINING UNDER ROOF STRUCTURE.

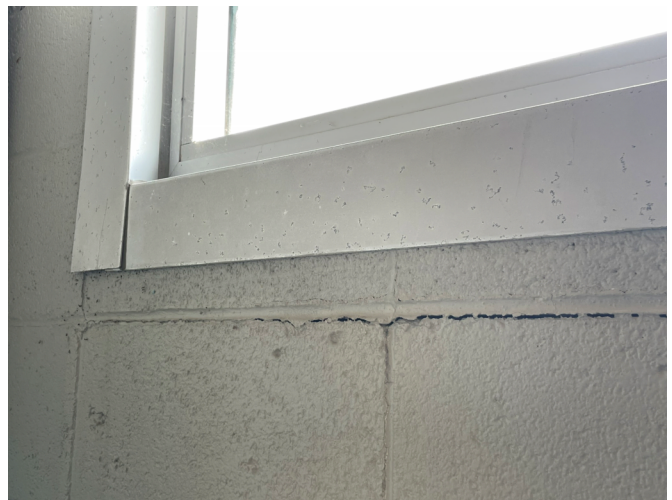
88. VIEW OF CRACK UNDER WINDOW.

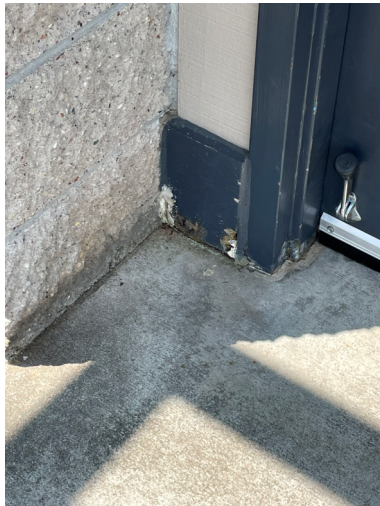
101. VIEW OF WORN WOOD TRIM BY SNACK BUILDING DOOR.

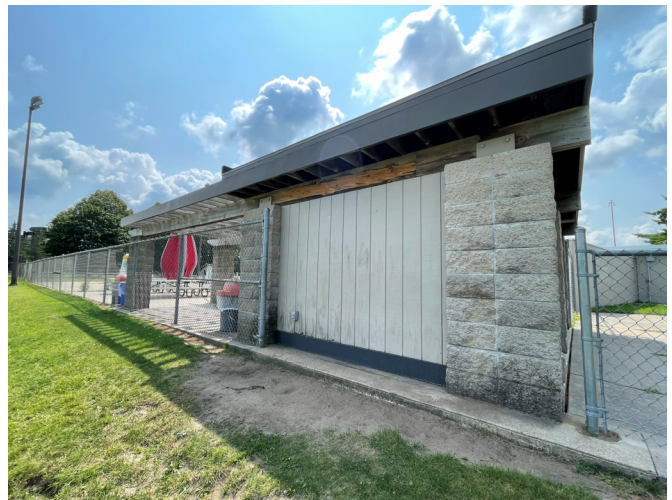
The snack building brings together a few façade materials, starting with a split-face block surround at each of the steel columns at the four corners of the main building. See photos 95, 96, and 97. Outer columns are constructed with similar block wrap, with the main trellis structure spanning the entirety of the space. The exposed wooden structure has greyed over time via a natural weathering process. Areas which transition back into mostly shadowed/covered areas maintain their original wood-look appearance, see photo 98. The condition of sitting the structure centered on these concrete block wraps, has allowed wildlife to nest upon the ledge and within the crevices created, see photos 99 and 100. There is some minor wear noticeable along the wood base trim and where it meets the pool deck; minor rusting at base of door frames similar to locker room doors, see photo 101. The exterior façade of the snack building facing away from the pool (outside of the fence enclosure) has signs of wear along the bottom of the vertical panelized siding. See photo 102.

102. VIEW OF WORN SIDING ON BACK OF SNACK BUILDING.

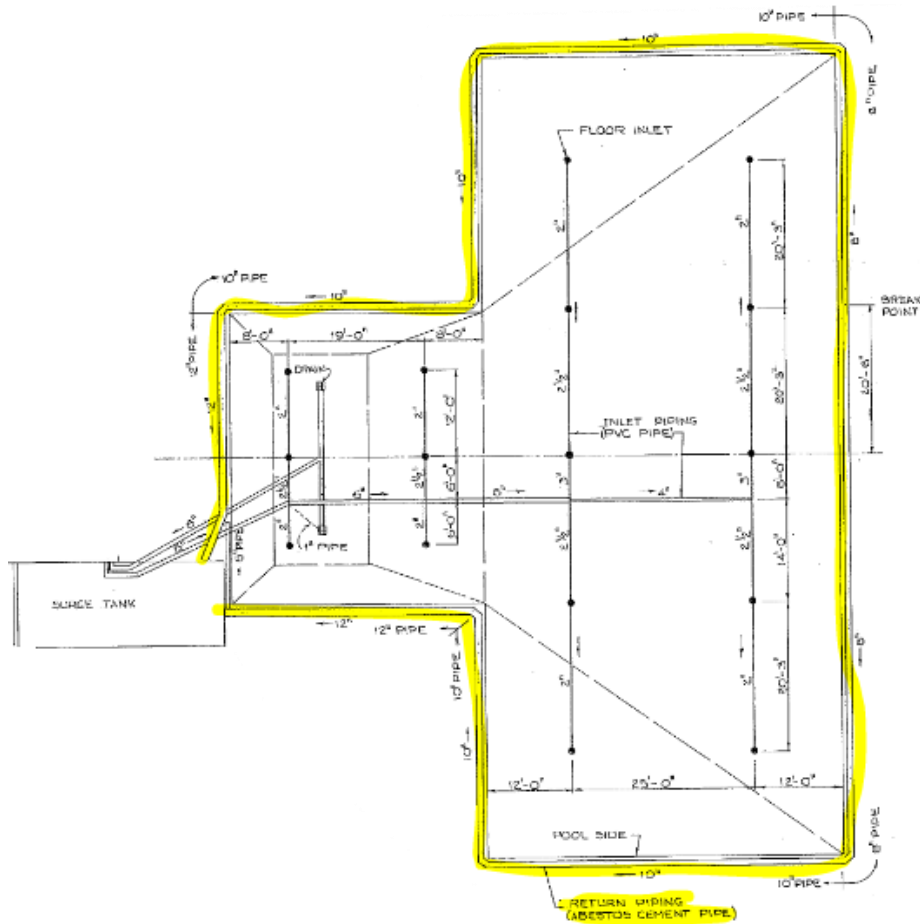
Figure 1 - Pool Piping Plan From 1977 Plans

1. Pool Piping: The majority of the piping is PVC, but the gutter piping is still the original asbestos cement piping. Replacement of the asbestos cement piping will require coordination with an abatement crew. The gutter piping was constructed into the pool wall around the perimeter. This would require the entire gutter, portions of the pool wall, and some deck equipment such as ladder railing and lifeguard chairs be removed in order to replace the gutter piping. See Figures 1 and 2 in **Appendix B** for the gutter piping shown in the plans developed in 1977. See photo 14.
