**REGULAR MEETING
Board of Park Commissioners
November 6, 2024 - 6:30 PM**

4. Review of preliminary condition report of Donald Copps Municipal Pool.

During the site visit, the pool was empty to allow for a close-up evaluation of the pool basins. The following items were noted based on the on-site evaluation, several discussions with City of Stevens Point staff, and review of previous construction plans.

This report provides a summary of noted concerns and potential improvements for consideration by the City of Stevens Point. Photographs can be found in **Appendix A** for reference. Initial photos 1, 2, and 3 provide an overall view of the existing pools at the facility.

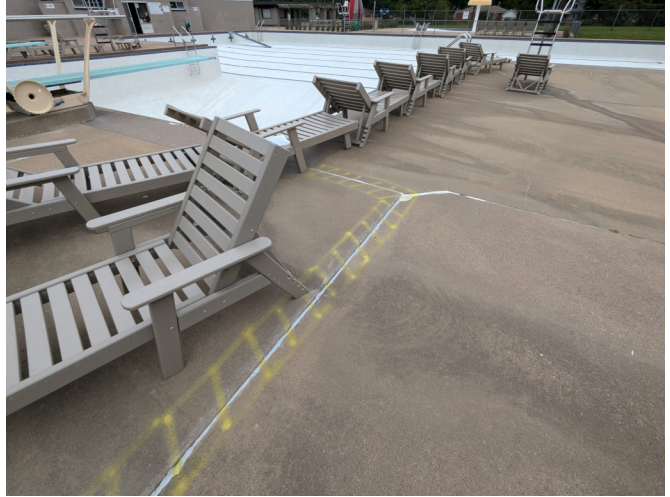
1. Main Pool Surge Tank Leak
 - a. Determined from the bucket tests and evaluation of the pool basin, the surge tank has a leak, causing the deck to settle.

4. VIEW OF LOCATION OF DECK SETTLEMENT.

2. Deck Settlement
 - a. Once the source of the leak is repaired in the surge tank, the existing deck that settled should be replaced to remove any potential tripping hazard in that area.

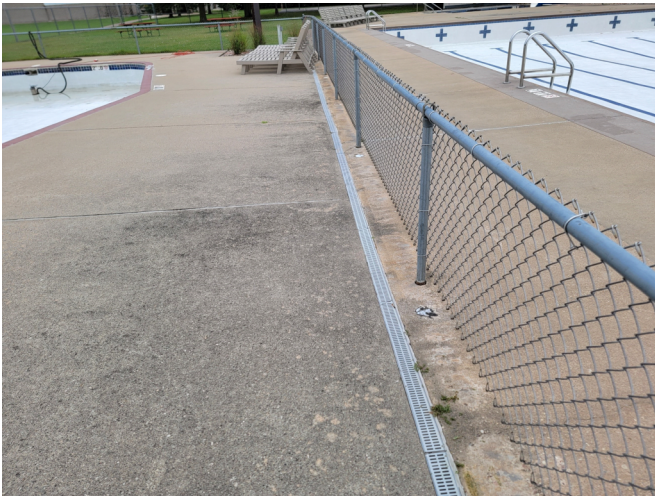
9. VIEW OF DECK DRAIN BETWEEN MAIN AND WADING POOLS.

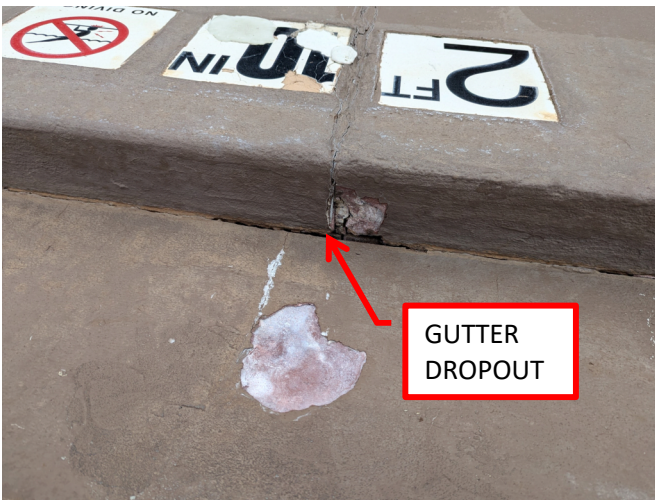
15. VIEW OF GUTTER DROPOUT AND CHIPPED PAINT IN GUTTER.

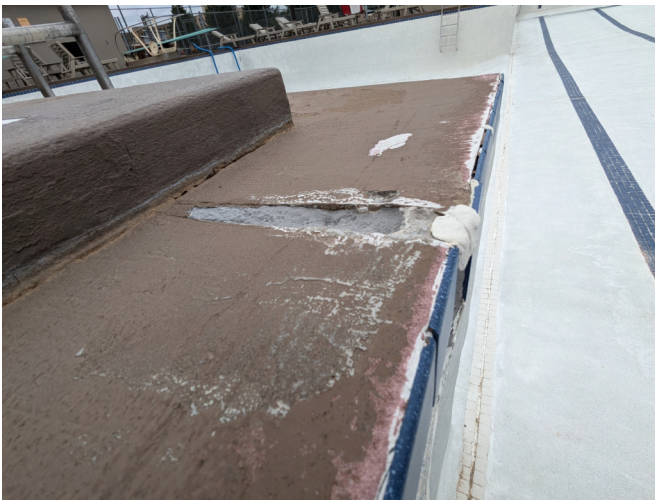
17. VIEW OF EXPANSION JOINT THROUGH GUTTER.

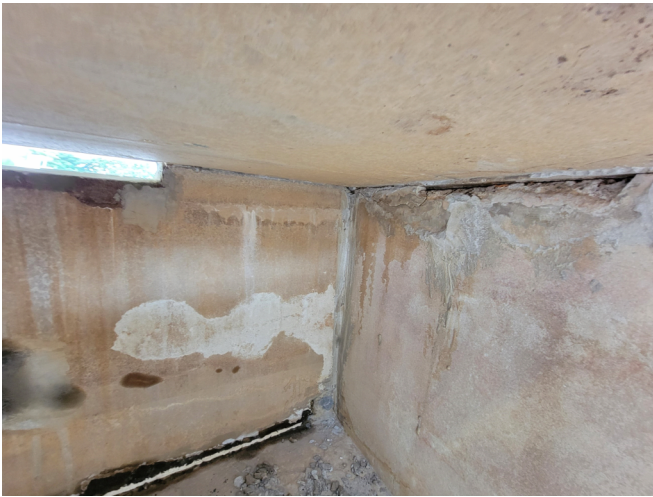
27. VIEW OF INSIDE WEIR TANK.

- b. All cracks in the pool basin and weir tank should be repaired to ensure the basin has a tight seal.

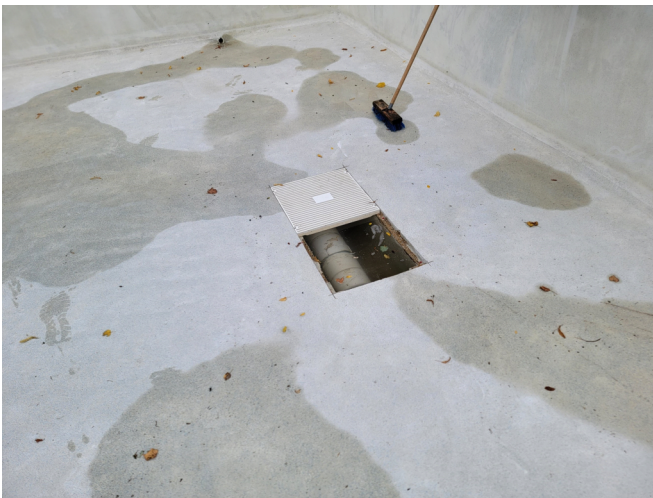
29. VIEW OF MAIN DRAIN IN PLUNGE POOL.

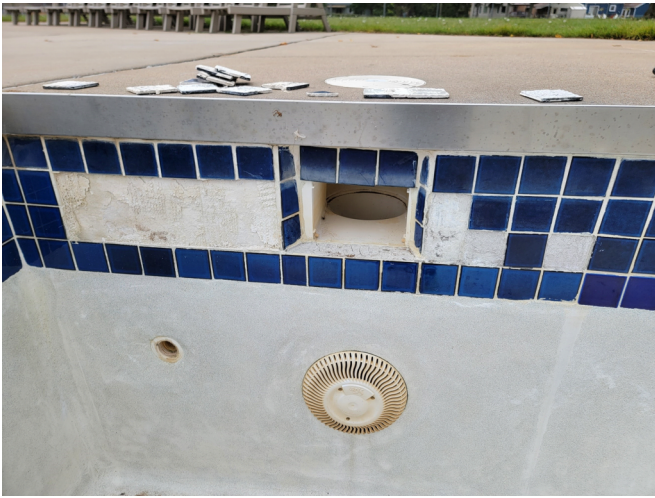
31. VIEW OF MISSING WATERLINE TILE AROUND SKIMMER.

1. Changing the power source of the ADA lift to remove the tripping hazard concern associated with the existing water powered lift.
2. Replace water line tile as necessary for all basins.
3. Add protection to the main pool heater piping that is exposed to the pool deck. This can be done using insulation or moving the existing fence to the edge of building.
4. Replace all broken depth marker tiles.
5. Repaint the slide flume terminus to match the remaining slide.
6. Remove corrosion and any sharp edges from stainless steel components around the facility. Adjust plunge pool handrails as necessary.
7. Provide additional bracing beneath the concrete counter in the men’s room to ensure it won’t break again.
8. Remove the corrosion on all door frames and repaint it to match the existing building.

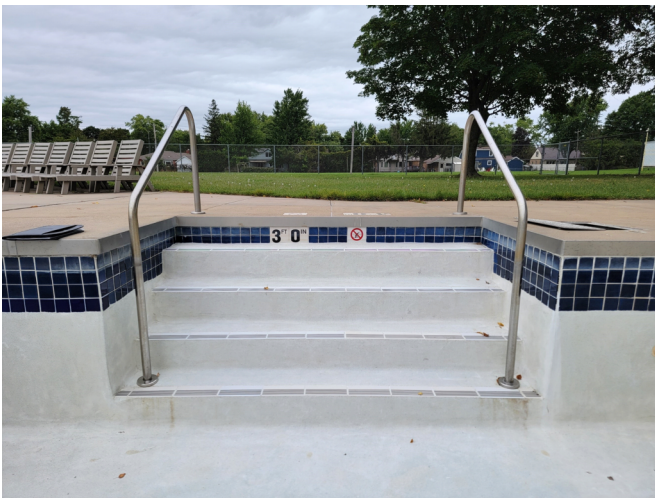
33. VIEW OF PLUNGE POOL STAIRS.

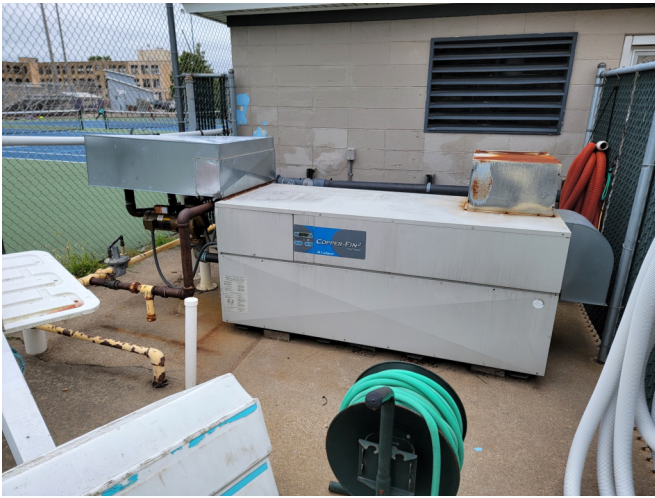
43. VIEW OF MAIN POOL HEATER.

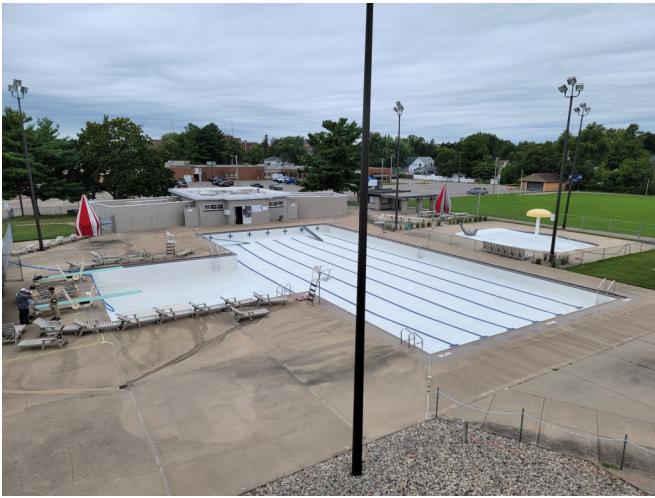
55. VIEW OF LIGHT POLE.

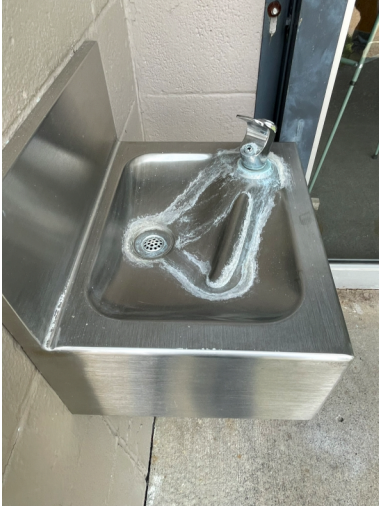
61. VIEW OF MINERAL STAINING ON DRINKING FOUNTAIN.

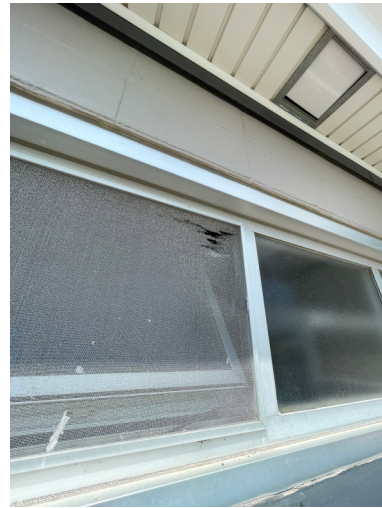
64. VIEW OF TEAR IN WINDOW SCREEN.

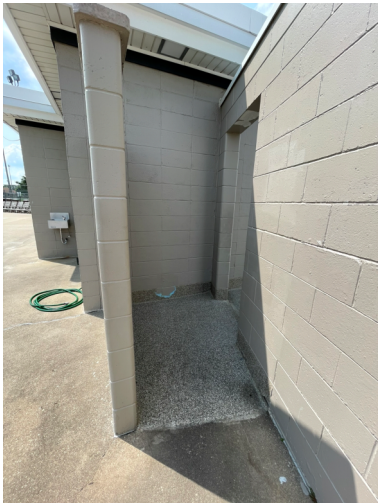
71. VIEW OF LOCKER ROOM WALKWAY TO POOL AREA.

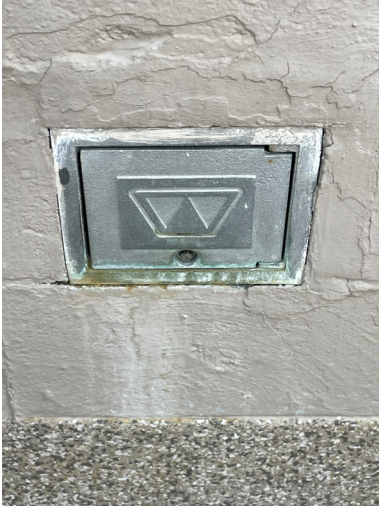
73. VIEW OF DISCOLORATION BELOW HOSE BIB.

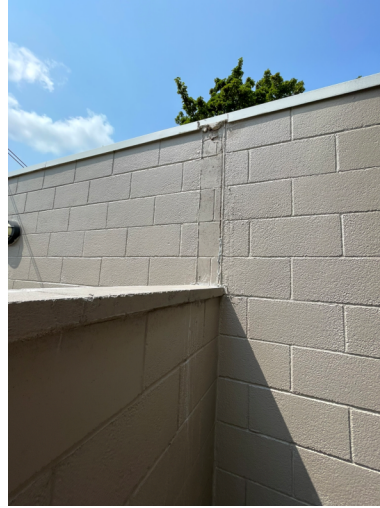
74. VIEW OF ROUGH JOINT AFTER WALL LOWERED.

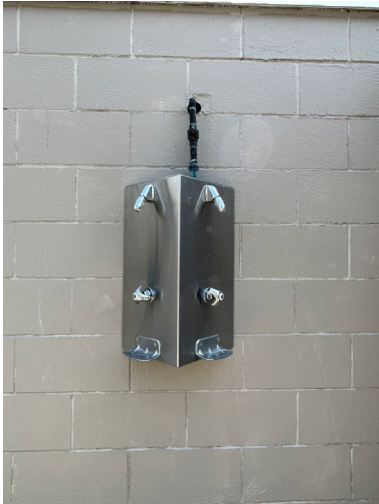
77. VIEW OF SHOWER FIXTURE.

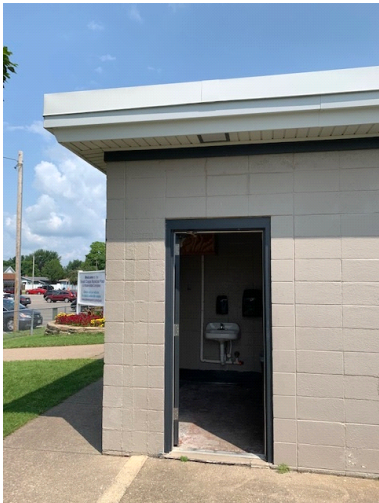
89. VIEW OF PUBLIC RESTROOM.

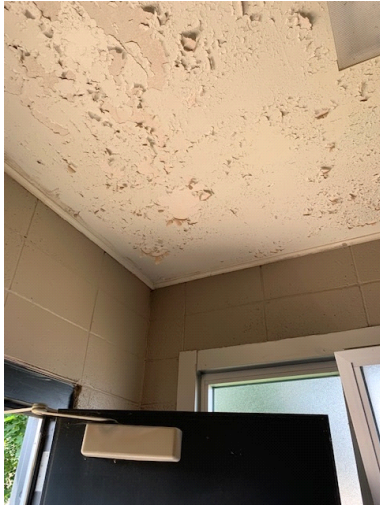
93. VIEW OF CEILING IN PUBLIC RESTROOM.

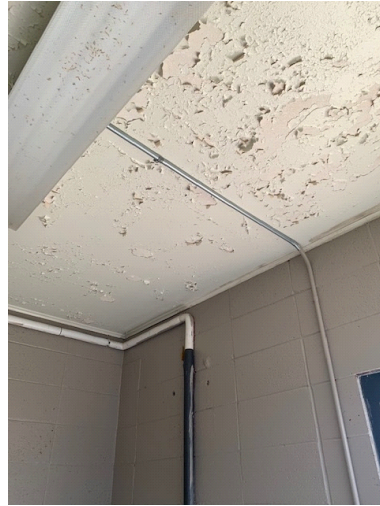
94. VIEW OF CEILING IN PUBLIC RESTROOM.

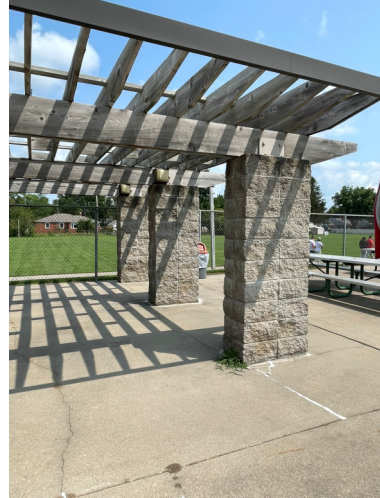
96. VIEW OF PERGULA AT SNACK BUILDING.

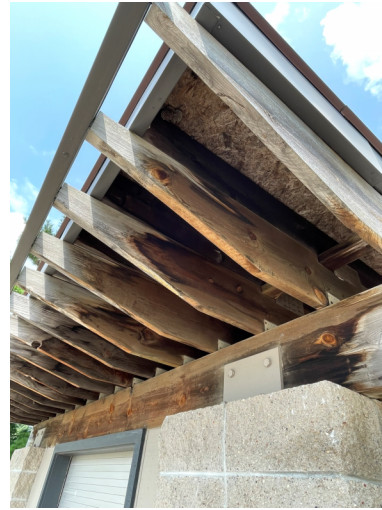
98. VIEW OF WEATHERED WOOD AT SNACK BUILDING.

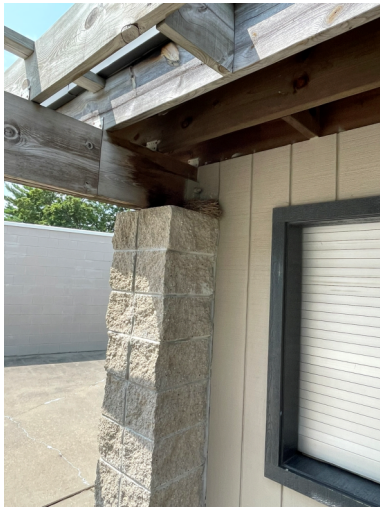
99. VIEW OF SNACK BUILDING COLUMN

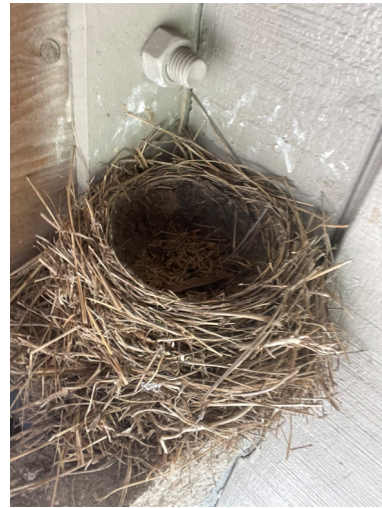
100. VIEW OF BIRD NEST ON SNACK BUILDING COLUMN.

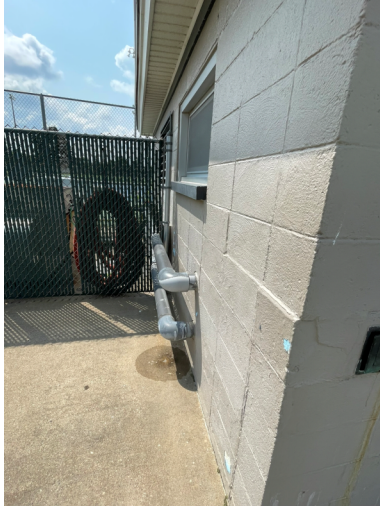
103. VIEW OF CHIPPED PAINT.

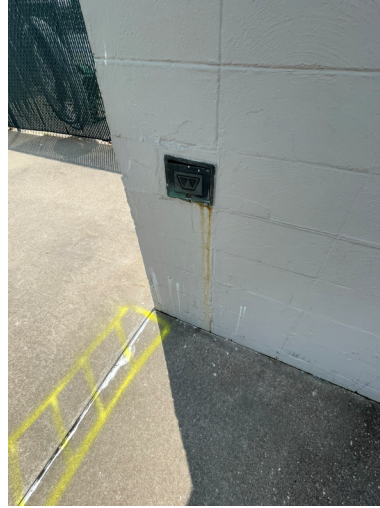
104. VIEW OF DISCOLORATION UNDER HOSE BIB.

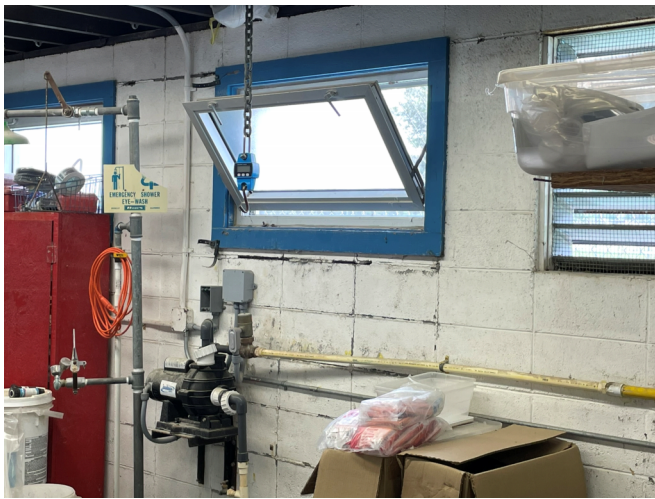
105. VIEW OF WINDOW IN MAIN POOL EQUIPMENT BUILDING.

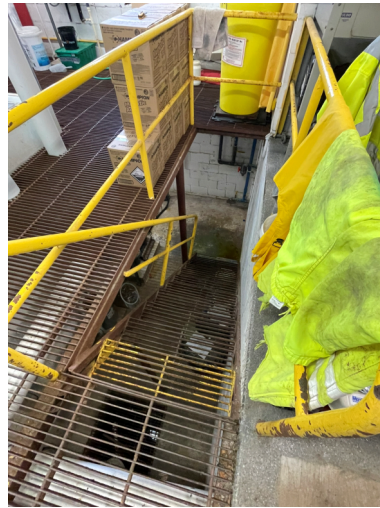
106. VIEW OF STAIRS IN MAIN POOL EQUIPMENT BUILDING.

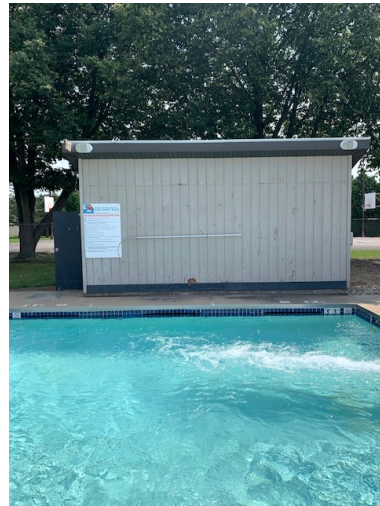
108. VIEW OF SECOND POOL EQUIPMENT BUILDING.

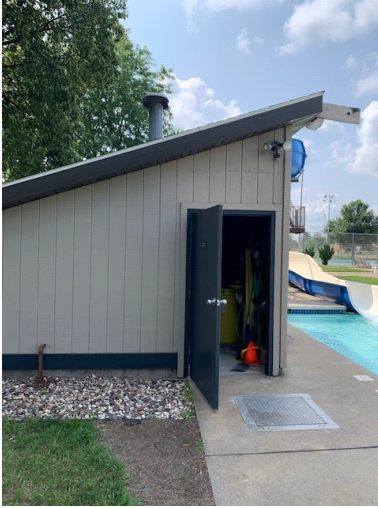
109. VIEW OF DOOR TO SECOND EQUIPMENT BUILDING.

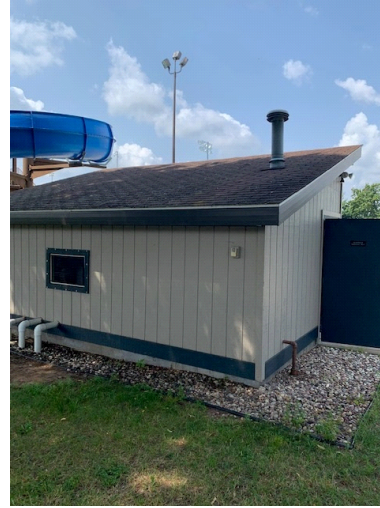
110. VIEW OF BACK OF SECOND EQUIPMENT BUILDING.

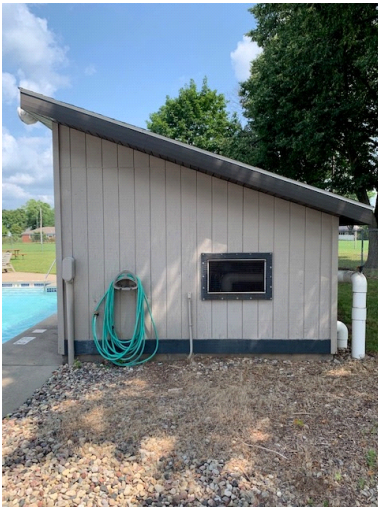
111. VIEW OF SIDE OF SECOND EQUIPMENT BUILDING.

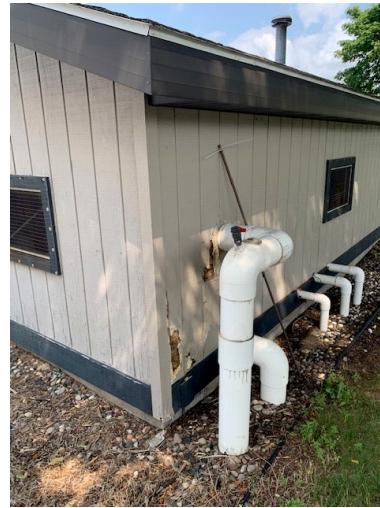
112. VIEW OF POOL PIPING FROM EQUIPMENT BUILDING.
