**REGULAR MEETING
Board of Park Commissioners
November 6, 2024 - 6:30 PM**

4. Review of preliminary condition report of Donald Copps Municipal Pool.

During the site visit, the pool was empty to allow for a close-up evaluation of the pool basins. The following items were noted based on the on-site evaluation, several discussions with City of Stevens Point staff, and review of previous construction plans.

This report provides a summary of noted concerns and potential improvements for consideration by the City of Stevens Point. Photographs can be found in **Appendix A** for reference. Initial photos 1, 2, and 3 provide an overall view of the existing pools at the facility.

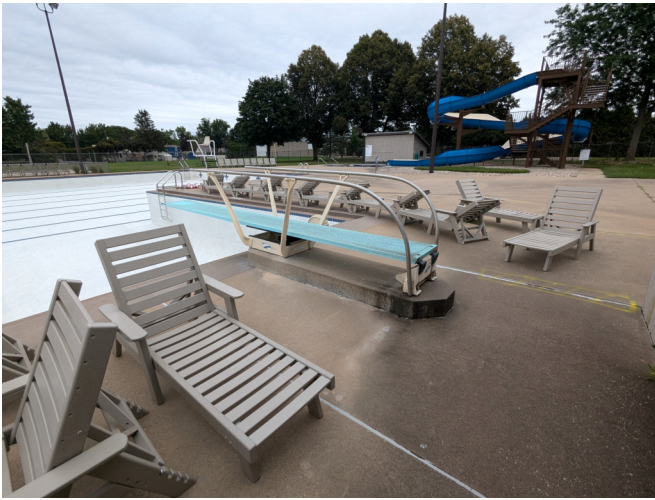
7. VIEW OF POOL DECK BEHIND DIVING BOARD.

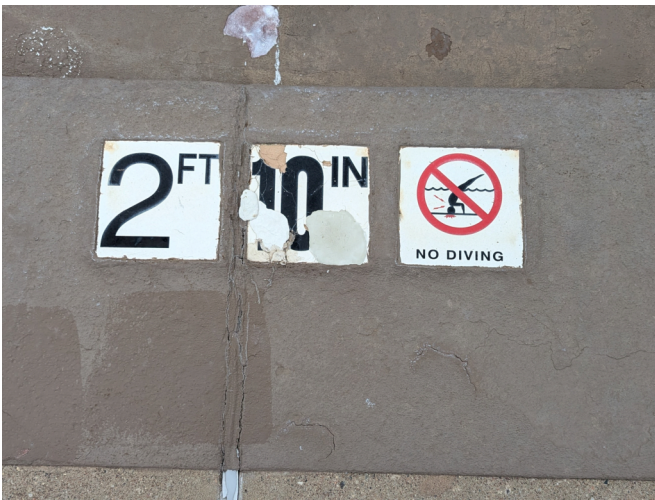
11. VIEW OF CHIPPED DEPTH MARKER.

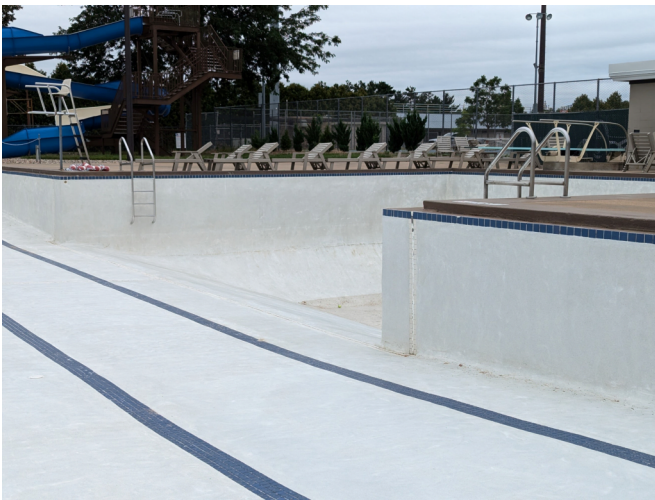
23. VIEW OF LADDERS IN DIVING HOPPER.

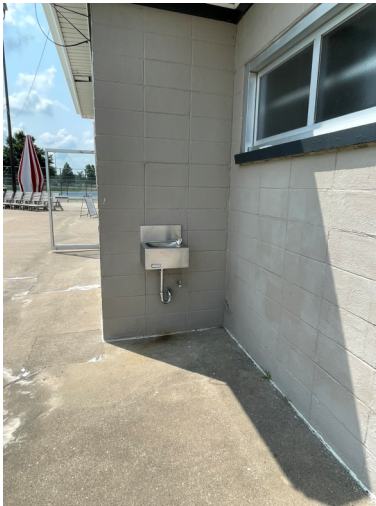
59. VIEW OF DRINKING FOUNTAIN.

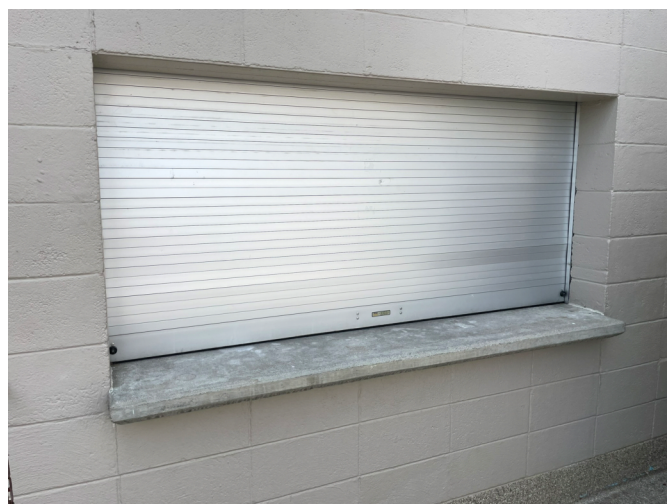
78. VIEW OF OVERHEAD WINDOW TO THE OFFICE.

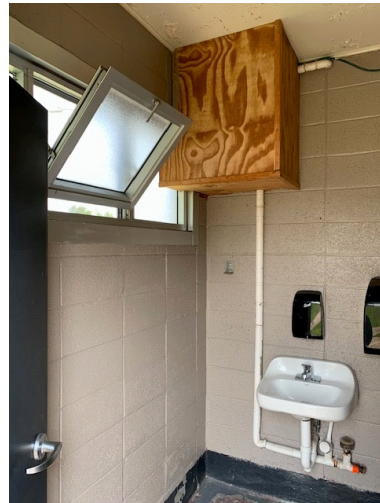
90. VIEW OF WINDOW IN PUBLIC RESTROOM.

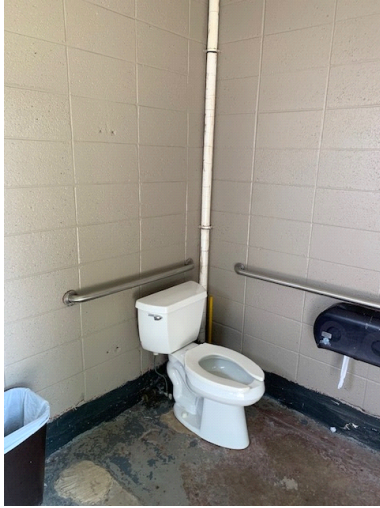
91. VIEW OF TOILET IN PUBLIC RESTROOM.

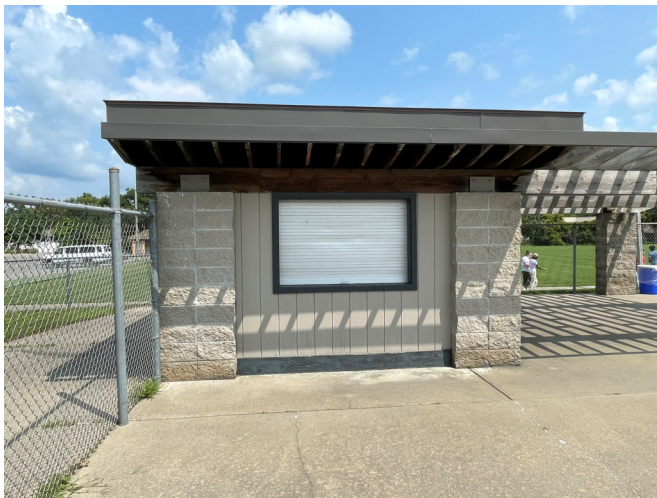
95. VIEW OF SNACK BUILDING.

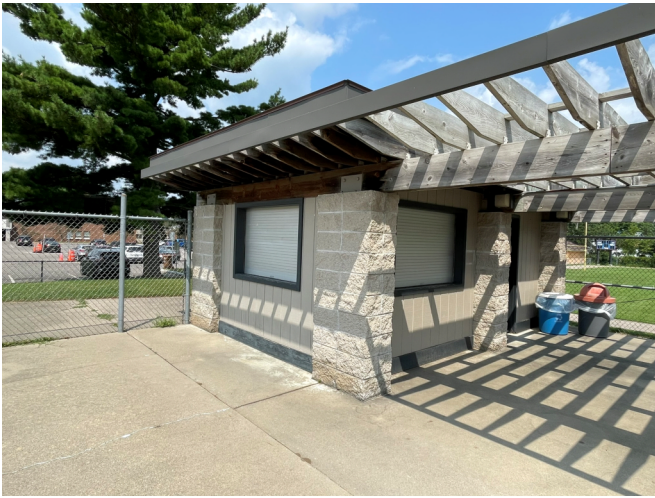
97. VIEW OF SNACK BUILDING.

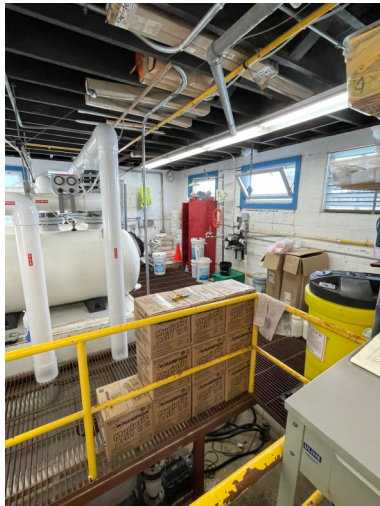
107. VIEW OF CHIPPED PAINT ON SAFETY RAILING.
